CHAPTER III

Achieving Seismic Safety in Buildings

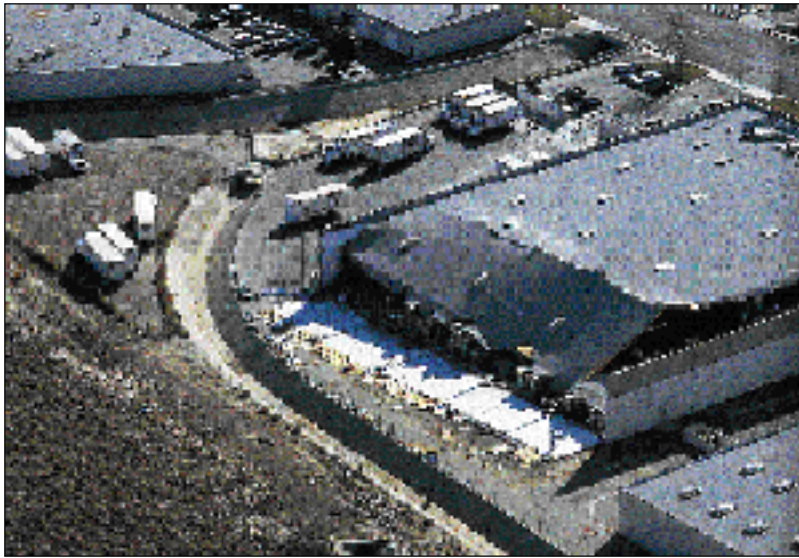
Figure 22. This industrial tilt-up building had its roof and wall partially collapse.

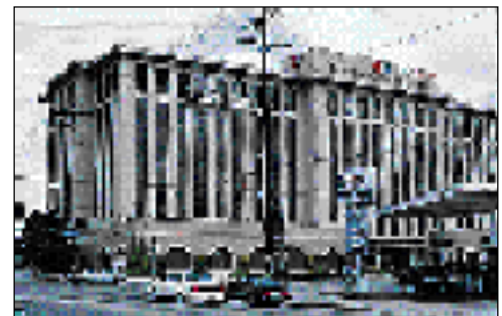
Figure 24. Cracks in slightly damaged steel buildings were often undetected until months after the earthquake.

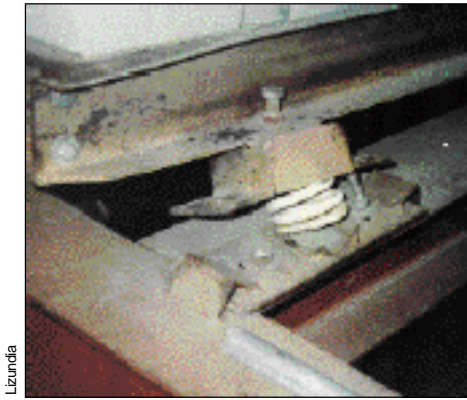
Figure 28. Broken supports on heating and ventilating equipment can render this equipment useless.

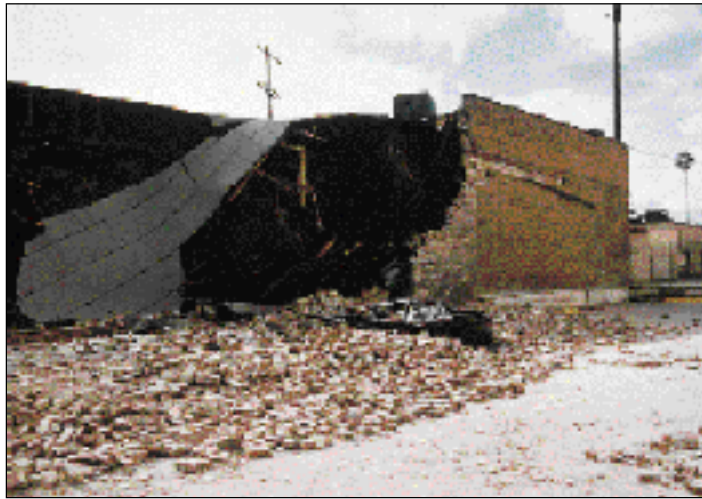
Figure 37. This retrofitted brick building collapsed in part because its wall braces were ineffective.

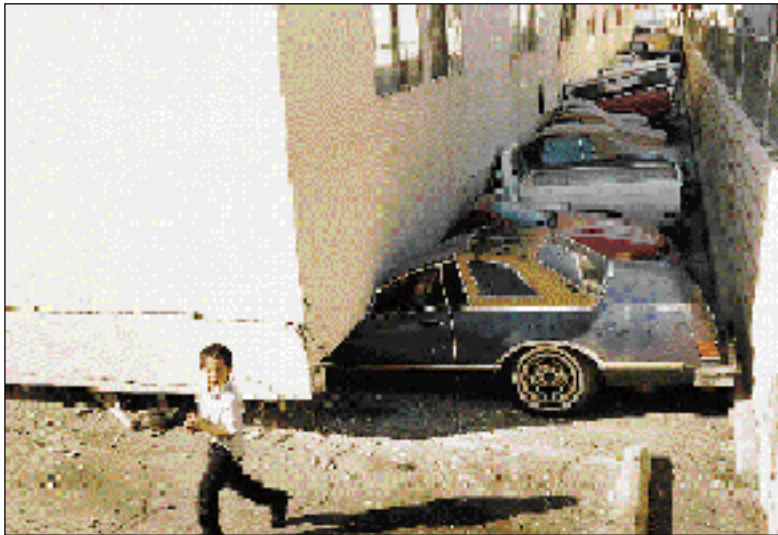
Figure 45. Older apartments like this with tuck-under parking collapsed because they were poorly braced.

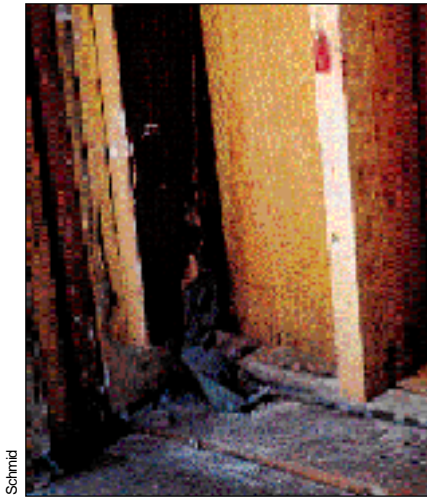
Figure 51. This metal connector stretched, distorted, and eventually caused the wood to split.

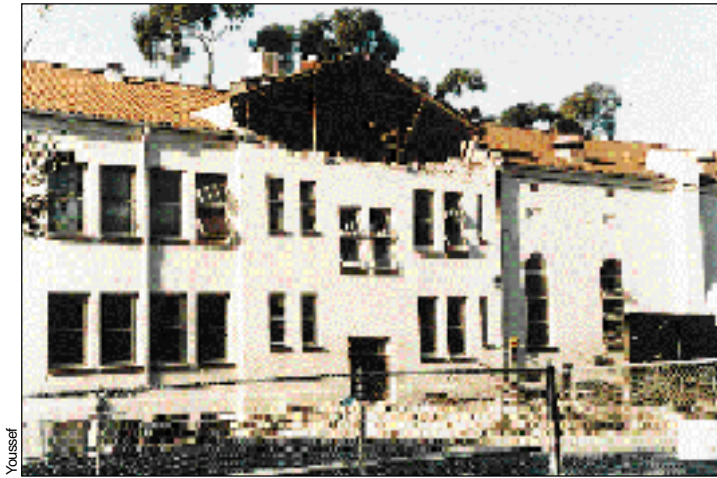
Figure 66. Life-threatening structural hazards such as this are still allowed in older private schools throughout California. Most of them have been eliminated in our public schools.
