CHAPTER III

Achieving Seismic Safety in Buildings

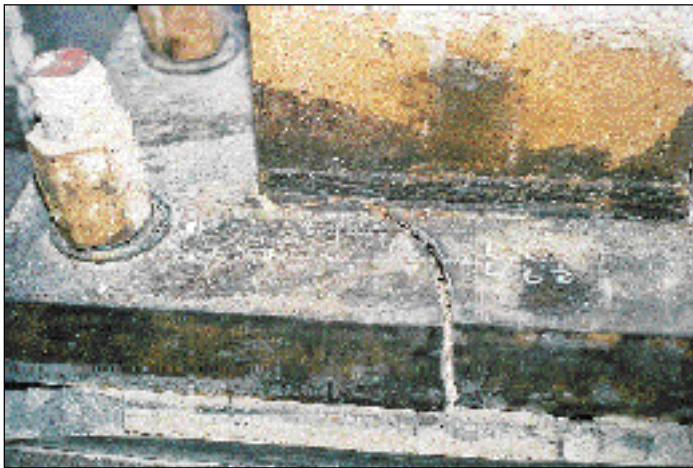
Figure 15. A 4-inch-thick steel plate supporting the base of a column at the Oviatt Library at CSU Northridge. The plate fractured when the building was violently shaken.

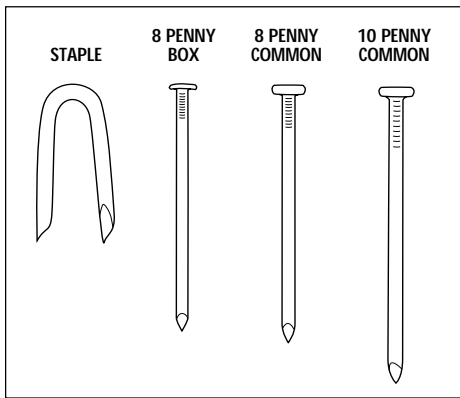
Figure 17. Smaller box nails and staples were routinely substituted for stronger common nails to reduce construction costs, also reducing earthquake resistance.

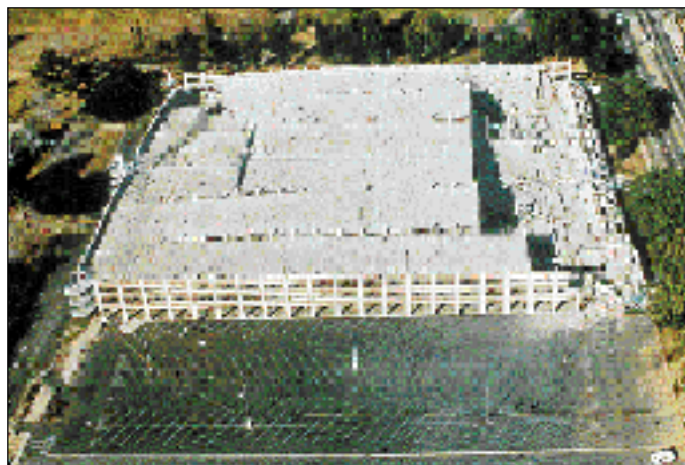
Figure 19. Constructed in 1991, this CSU Northridge parking structure collapsed when interior columns failed.

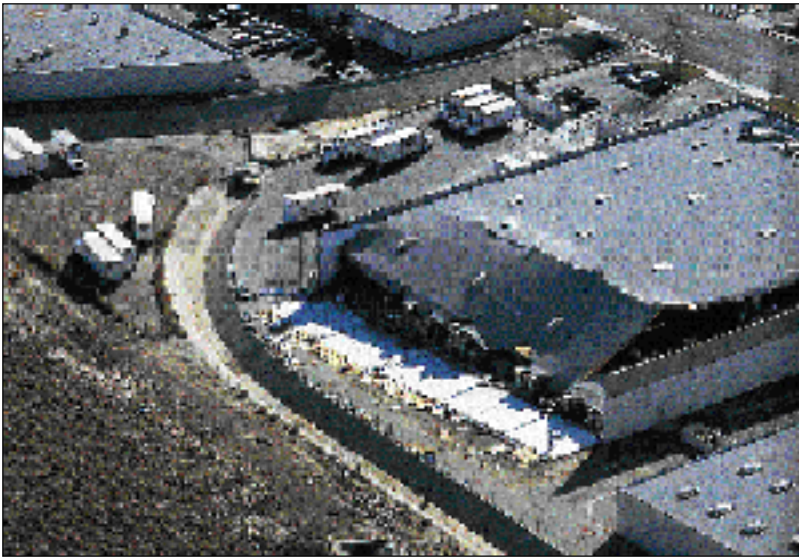
Figure 22. This industrial tilt-up building had its roof and wall partially collapse.

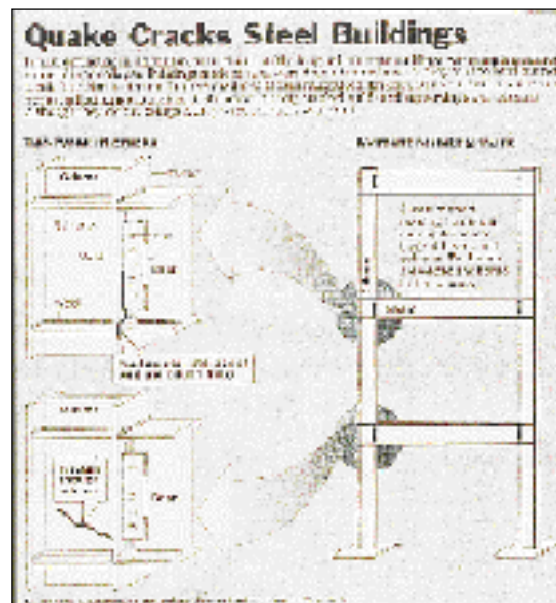
Figure 23. Though no steel-frame buildings collapsed, cracks in connections have stimulated efforts to substantiate building code requirements.

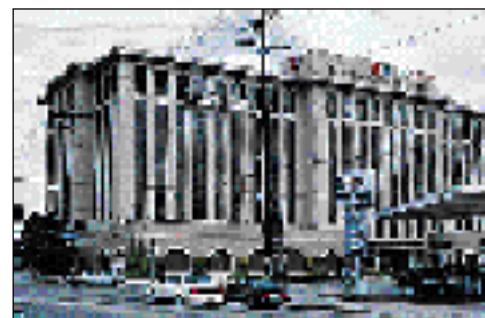
Figure 24. Cracks in slightly damaged steel buildings were often undetected until months after the earthquake.

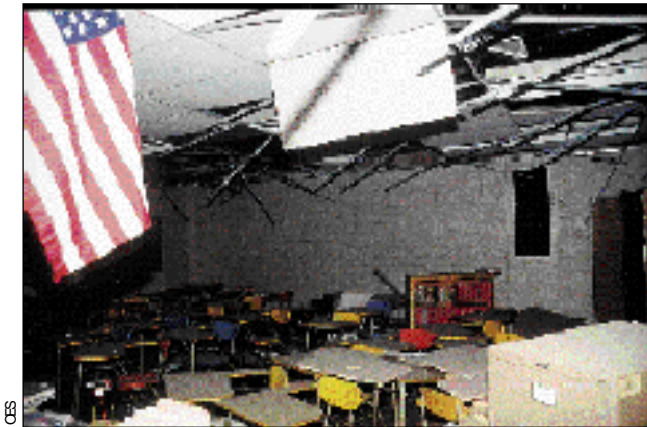
Figure 25. Though falling acoustic ceiling tiles like this are not particularly dangerous, falling light fixtures and other heavier elements can be.

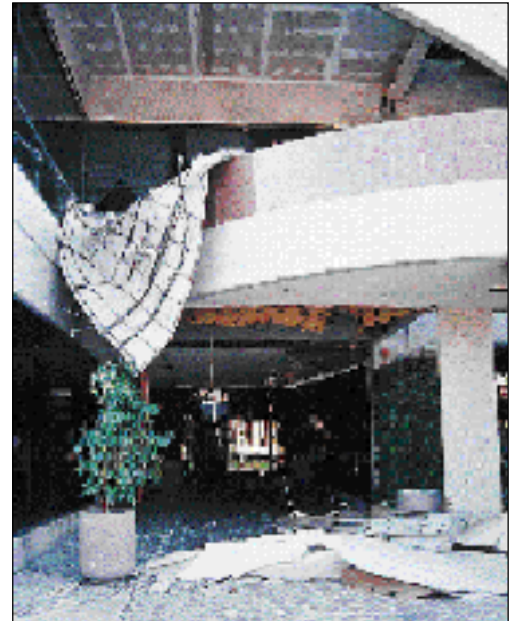
Figure 26. Heavy plaster ceilings or soffits can pose serious risks to occupants.

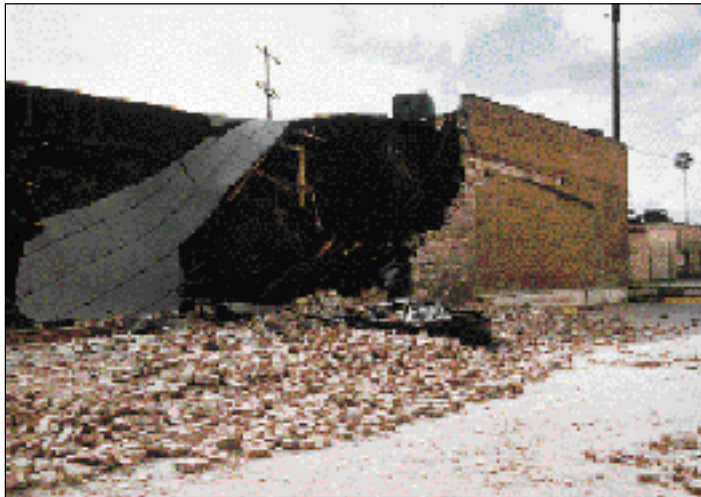
Figure 37. This retrofitted brick building collapsed in part because its wall braces were ineffective.

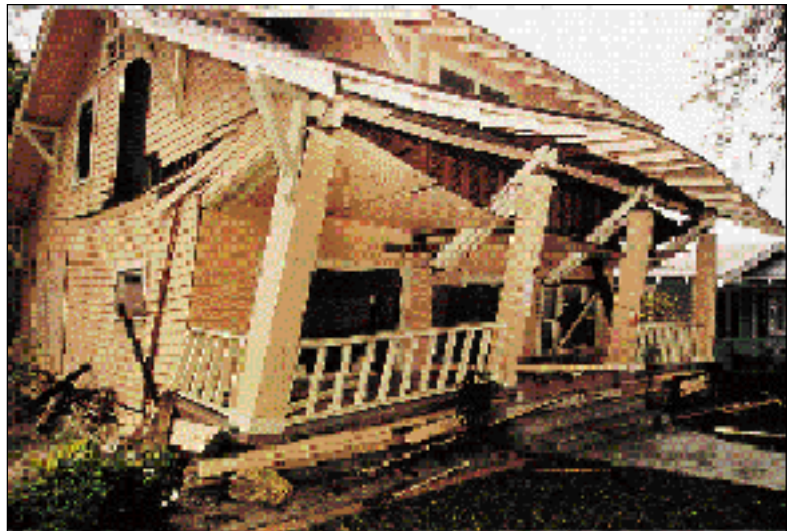
Figure 44. Older homes with horizontal wood siding are particularly vulnerable to damage if they are not securely fastened to a proper foundation.

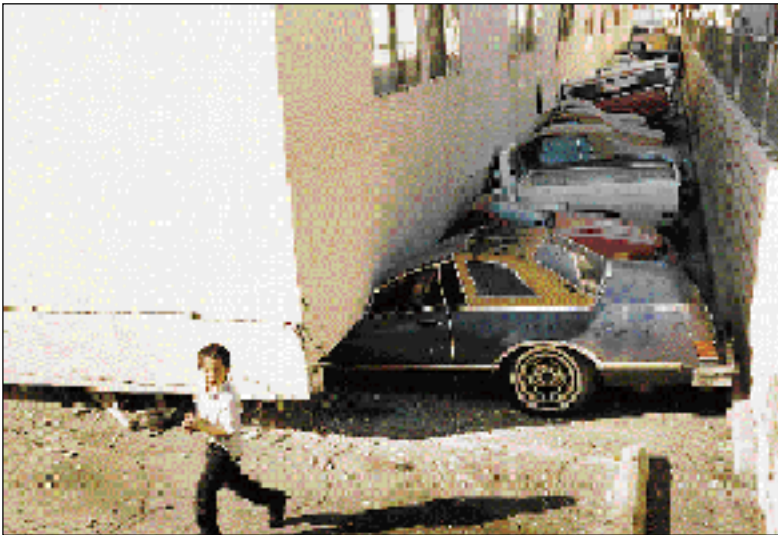
Figure 45. Older apartments like this with tuck-under parking collapsed because they were poorly braced.

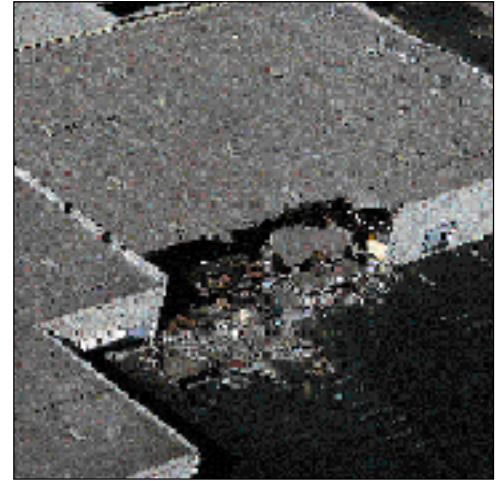
Figure 49. Damage to both new and older tilt-up buildings was widespread.

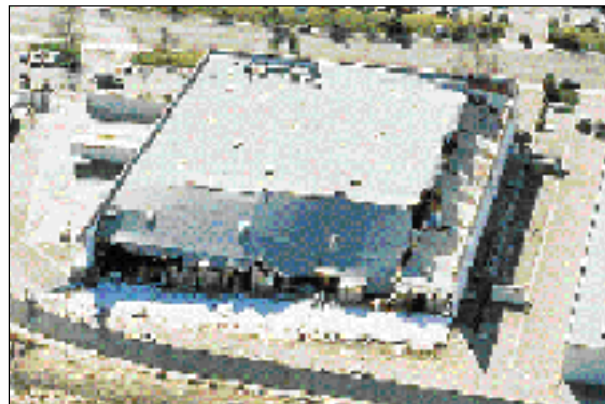
Figure 50. Despite changes to the building code made shortly after the 1971 earthquake, failures occurred in tilt-up buildings.

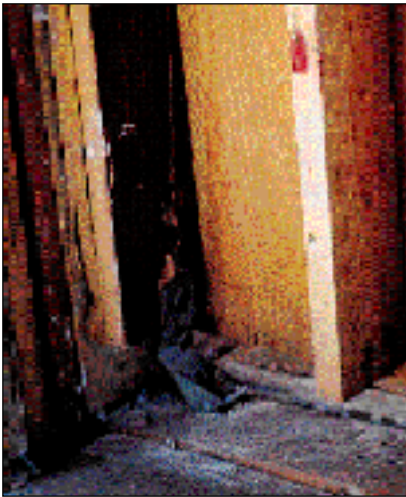
Figure 52. Connections between the roof and floor slabs and the columns failed in this collapsed building.

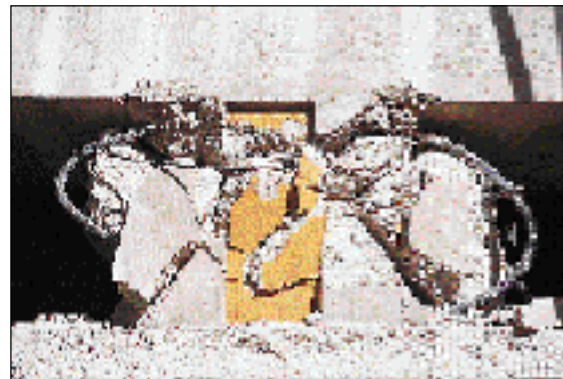
Figure 55. Short columns in this parking structure failed. Modern building codes now require much more reinforcing steel for such short columns.

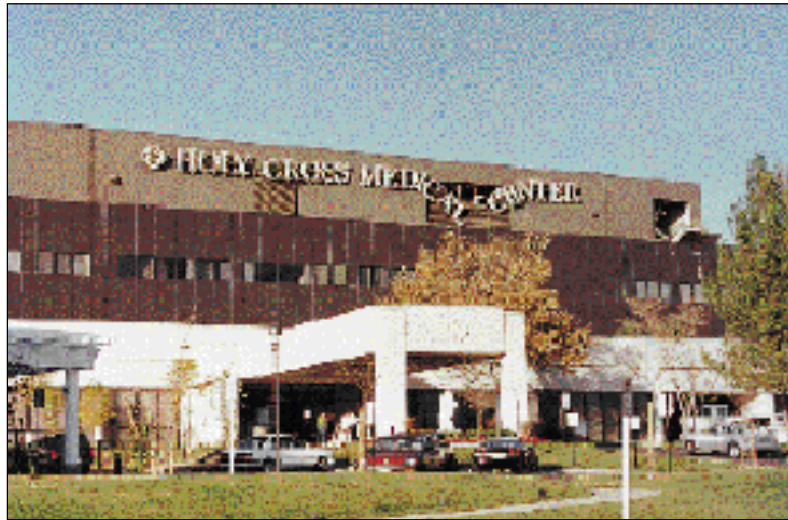
Figure 57. Damage to the heating and ventilation system in this hospital shut it down for a week. Months later, additional structural damage to steel connections was discovered and repaired.

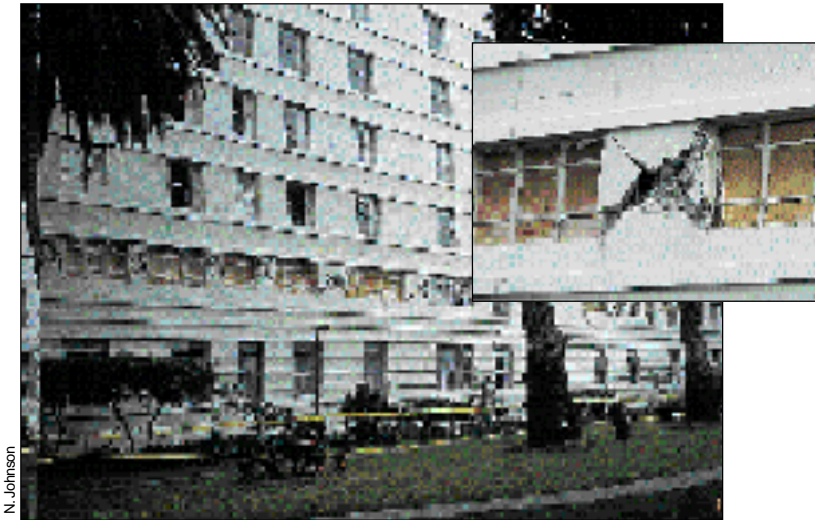
Figure 58. This older hospital was severely damaged. Lightly reinforced concrete walls lost much of their strength when X cracks formed. *Inset, detail.*

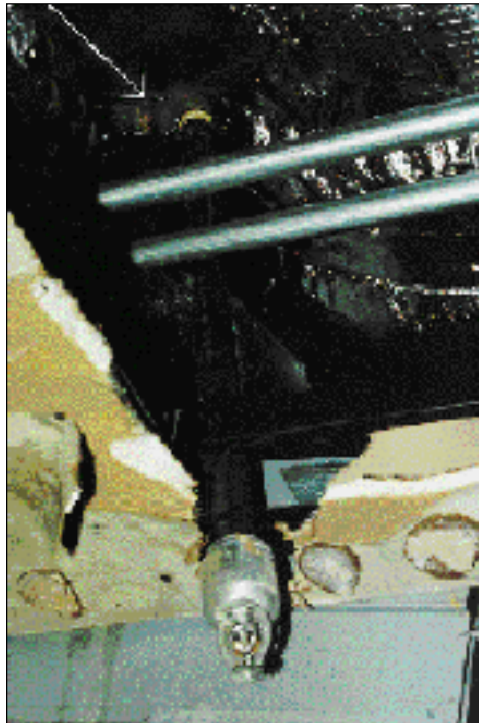
Figure 59. Water from failed sprinkler lines produced costly damage and disruption.

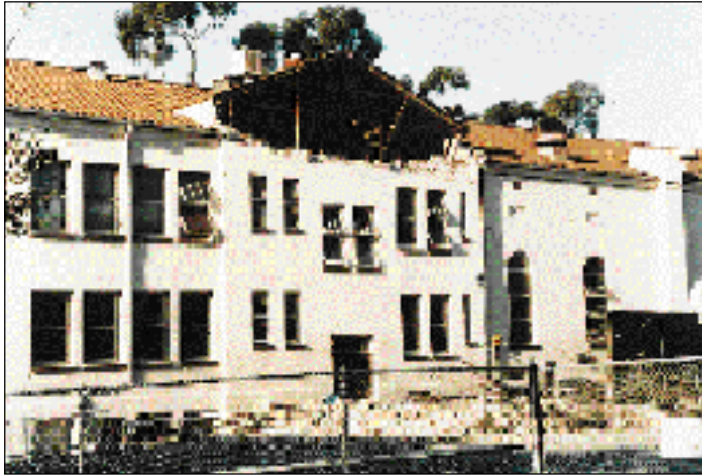
Figure 66. Life-threatening structural hazards such as this are still allowed in older private schools throughout California. Most of them have been eliminated in our public schools.
