CHAPTER IV

Achieving Seismic Safety in Lifelines

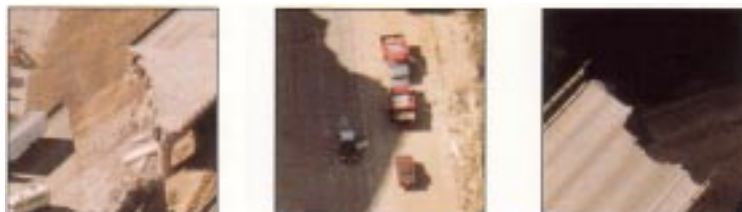
%% Roadbed sections of part of Interstate 5 fell off their supports.

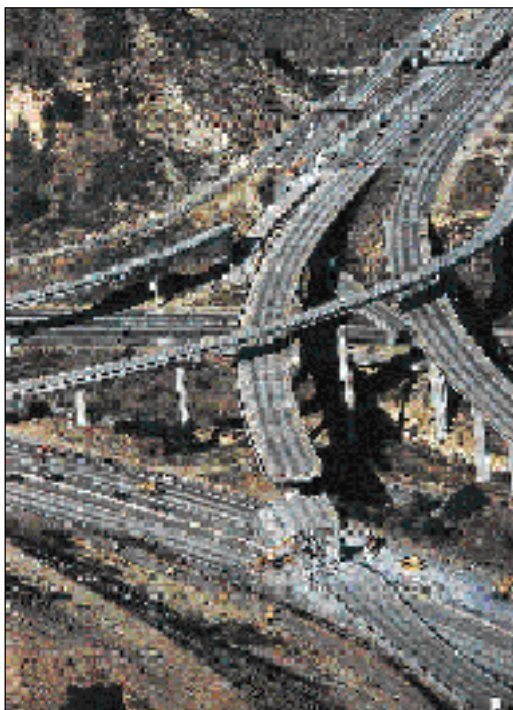
The interchange of State Route 14 and Interstate 5 (see Figure 68 for locations) was badly damaged in the 1971 San Fernando earthquake, but the two structures that collapsed in the Northridge earthquake, the North and South Connector overcrossings, were designed before 1971. At that time it was believed that improved hinge restrainers would be adequate to prevent collapse. Though they contain some pre-1971 design details, hinge restrainers were added to both bridges. During the Northridge earthquake, brittle shear failures in short stiff columns next to the abutments initiated the collapse of both bridges as shown in Figure 69. After the columns failed in shear and were crushed by the weight of the decks, the decks were pulled from their supporting abutments. As the decks fell, they failed by bending at the adjacent piers. These failures demonstrated that retrofitting such structures with hinge restrainers alone may not be adequate. Retrofitting the single-column piers to

prevent brittle shear, moment, and foundation failures may also be needed. Caltrans has incorporated this observation in the design of both retrofitted and new projects.

Figure 69. Two overpass collapses at the I-5/SR-14 interchange were started by failures in short, stiff columns.

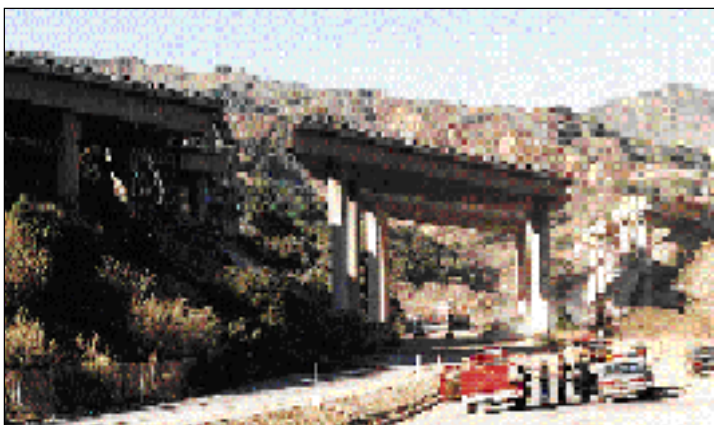
Although no steel-girder bridges collapsed during the Northridge earthquake, four bridges of this type, in a three-mile segment of Interstate 5 near the City of Newhall, sustained significant structural damage (Astaneh-Asl et al., 1994). These bridges are the Pico-Lyons Overcrossing, the Santa Clara River Bridge, the Valencia Boulevard Overcrossing, and the Old Road Bridge over the Santa Clara River.

Figure 70. Deck sections fell off their seats at the Gavin Canyon Undercrossing on I-5.

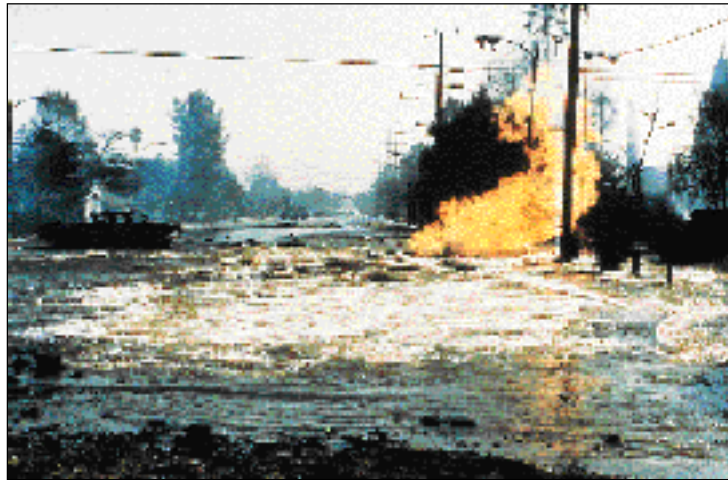
The Northridge earthquake also illustrated, as have previous earthquakes, that modern pipe of steel and other materials performs well even when subjected to intense shaking and moderate levels of ground displacement. Most of the problems in transmission pipe appear to have been related to weld failures in oxyacetylene-welded steel pipe installed before 1932, when welding procedures were inferior to those currently used (O'Rourke and Palmer, 1994). The natural-gas fire on Balboa Boulevard, Figure 71, was from an older pipeline in an area where significant ground deformation occurred; the resulting fire engulfed five nearby homes.

Figure 71. Fire and flood produced calamity at Balboa Boulevard's ruptured gas and water mains.

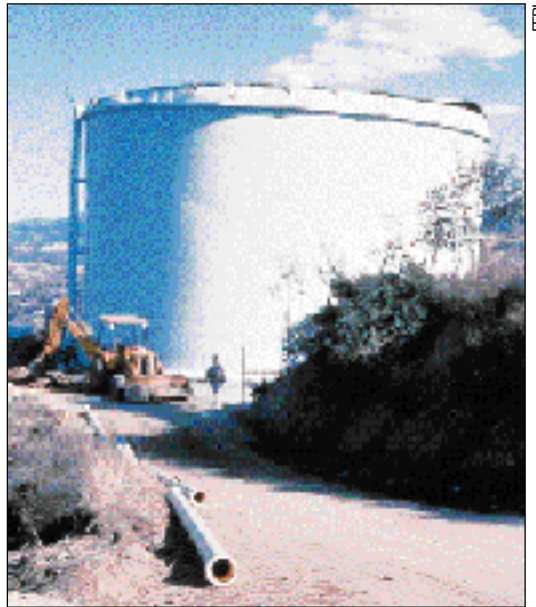
There was also extensive damage to older aboveground steel water tanks. In several cases, the entire contents of the tank were lost because of failures of inlet-outlet piping, which generally occurred because the ground shifted under the tanks. Other failures included buckling at the base of tanks, buckling of the shells, and roof damage. Because these storage facilities may represent the only immediate water supply for local systems, special measures must be employed to ensure their integrity after earthquakes (see Figure 72).

Figure 72. The walls of this water tank buckled; pipes ruptured and lost 800,000 gallons.

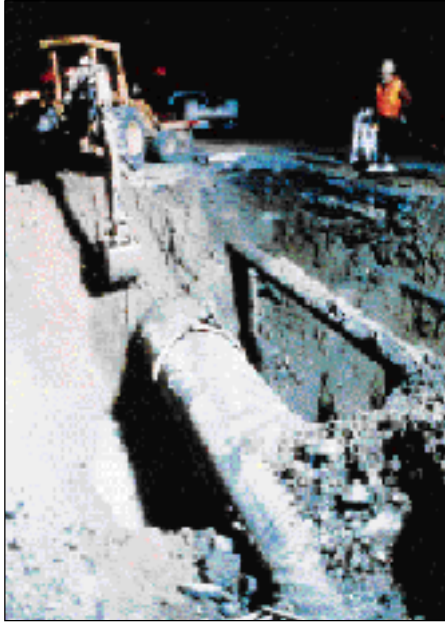
supply components in this and future earthquakes requires further investigation. In particular, large-diameter welded-steel pipelines with lap-welded joints must be analyzed to determine their threshold of earthquake failure. These pipelines are common within the water transmission system; if widespread damage to them were to occur, the water supply to the southern California region could be seriously disrupted. All the major pipelines bringing water into the Los Angeles basin from northern California cross areas where large damaging earthquakes are expected, and most of them

could be put out of service by a single event (Figure 73). Similar situations exist in northern California.

Figure 73. This four-foot-diameter water main under Balboa Boulevard buckled and ruptured when surrounding soils compressed it.
