CHAPTER IV

Achieving Seismic Safety in Lifelines

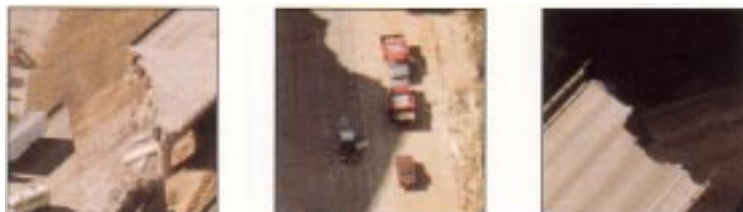
% Roadbed sections of part of Interstate 5 fell off their supports.

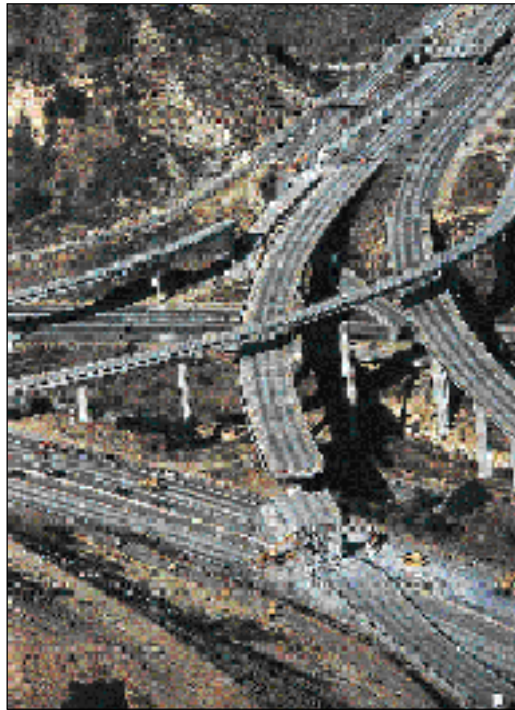
The interchange of State Route 14 and Interstate 5 (see Figure 68 for locations) was badly damaged in the 1971 San Fernando earthquake, but the two structures that collapsed in the Northridge earthquake, the North and South Connector overcrossings, were designed before 1971. At that time it was believed that improved hinge restrainers would be adequate to prevent collapse. Though they contain some pre-1971 design details, hinge restrainers were added to both bridges. During the Northridge earthquake, brittle shear failures in short stiff columns next to the abutments initiated the collapse of both bridges as shown in Figure 69. After the columns failed in shear and were crushed by the weight of the decks, the decks were pulled from their supporting abutments. As the decks fell, they failed by bending at the adjacent piers. These failures demonstrated that retrofitting such structures with hinge restrainers alone may not be adequate. Retrofitting the single-column piers to

prevent brittle shear, moment, and foundation failures may also be needed. Caltrans has incorporated this observation in the design of both retrofitted and new projects.

Figure 69. Two overpass collapses at the I-5/SR-14 interchange were started by failures in short, stiff columns.

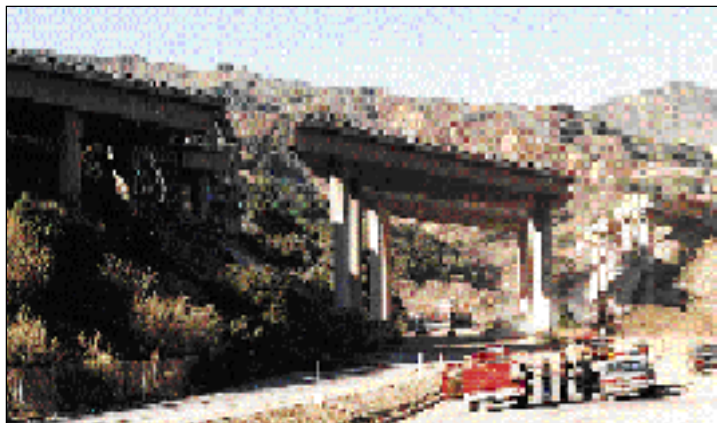
Although no steel-girder bridges collapsed during the Northridge earthquake, four bridges of this type, in a three-mile segment of Interstate 5 near the City of Newhall, sustained significant structural damage (Astaneh-Asl et al., 1994). These bridges are the Pico-Lyons Overcrossing, the Santa Clara River Bridge, the Valencia Boulevard Overcrossing, and the Old Road Bridge over the Santa Clara River.

Figure 70. Deck sections fell off their seats at the Gavin Canyon Undercrossing on I-5.

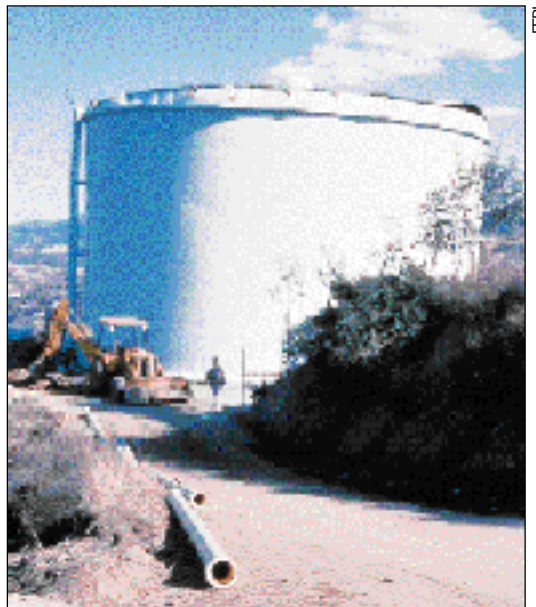
There was also extensive damage to older aboveground steel water tanks. In several cases, the entire contents of the tank were lost because of failures of inlet-outlet piping, which generally occurred because the ground shifted under the tanks. Other failures included buckling at the base of tanks, buckling of the shells, and roof damage. Because these storage facilities may represent the only immediate water supply for local systems, special measures must be employed to ensure their integrity after earthquakes (see Figure 72).

Figure 72. The walls of this water tank buckled; pipes ruptured and lost 800,000 gallons.

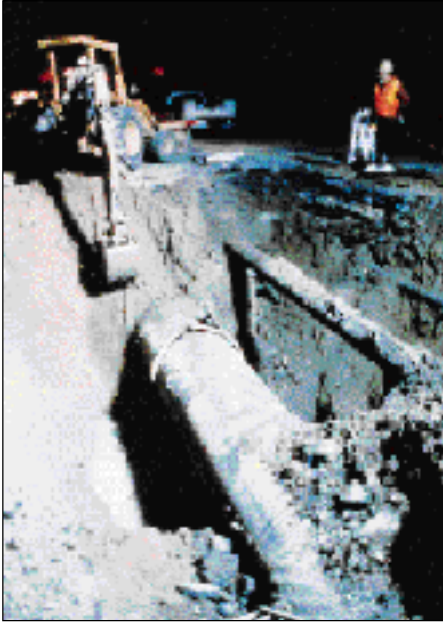
could be put out of service by a single event (Figure 73). Similar situations exist in northern California.

Figure 73. This four-foot-diameter water main under Balboa Boulevard buckled and ruptured when surrounding soils compressed it.
