CHAPTER III

Achieving Seismic Safety in Buildings

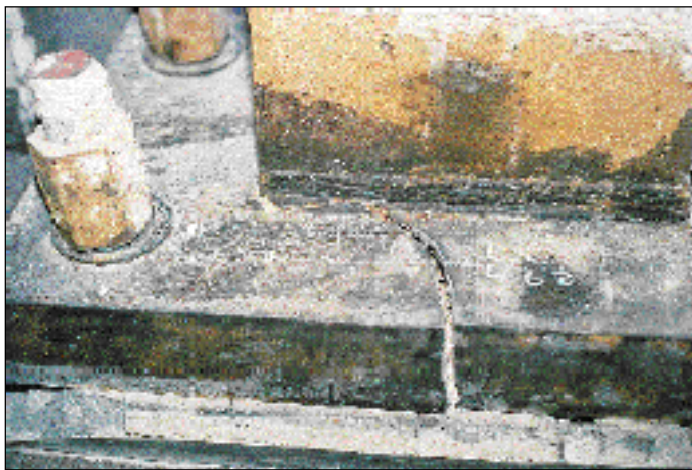
Figure 15. A 4-inch-thick steel plate supporting the base of a column at the Oviatt Library at CSU Northridge. The plate fractured when the building was violently shaken.

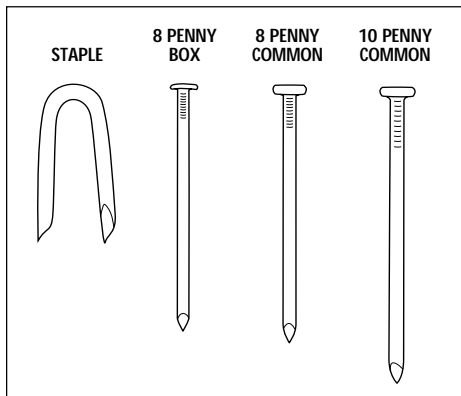
Figure 17. Smaller box nails and staples were routinely substituted for stronger common nails to reduce construction costs, also reducing earthquake resistance.

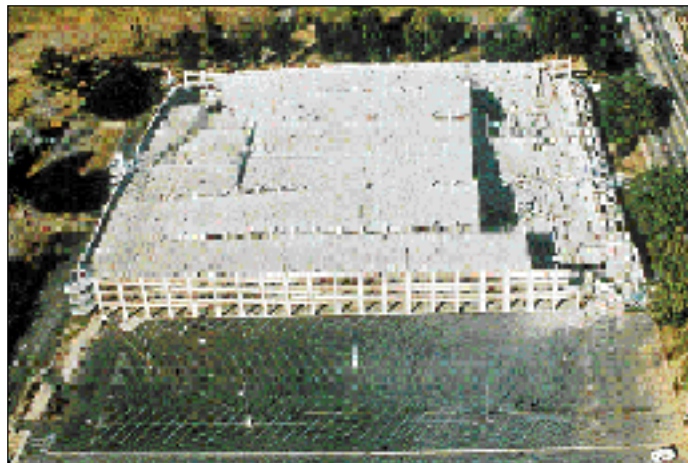
Figure 19. Constructed in 1991, this CSU Northridge parking structure collapsed when interior columns failed.

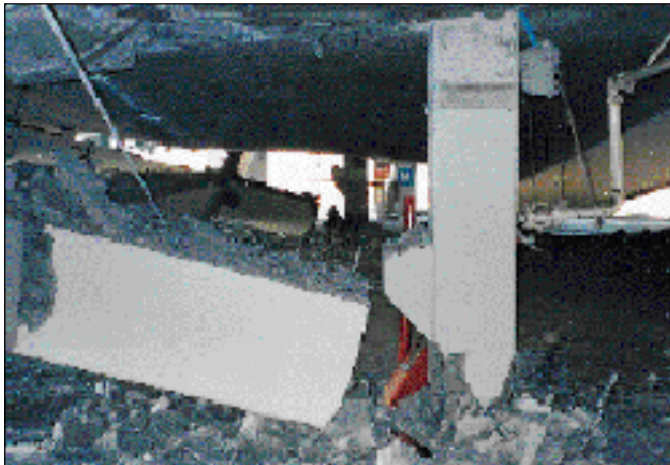
Figure 20. Interior columns failed and girders fell off supports in this CSU Northridge parking structure.

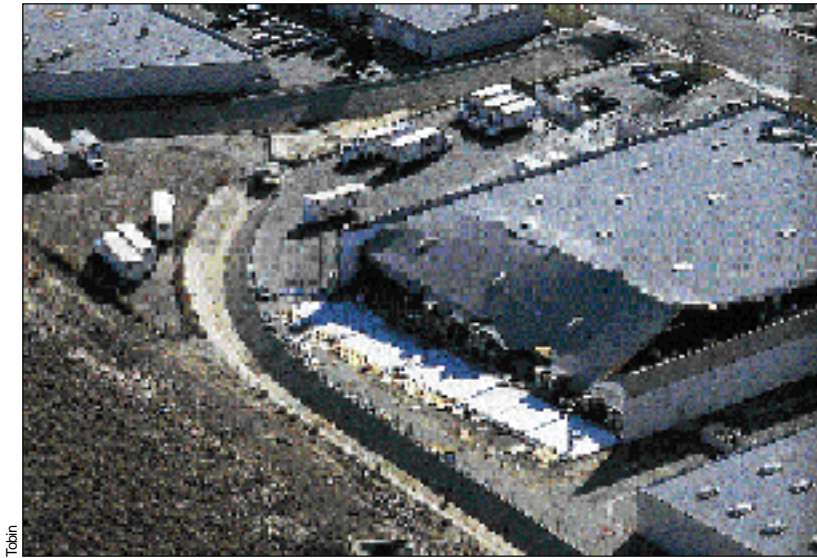
Figure 22. This industrial tilt-up building had its roof and wall partially collapse.

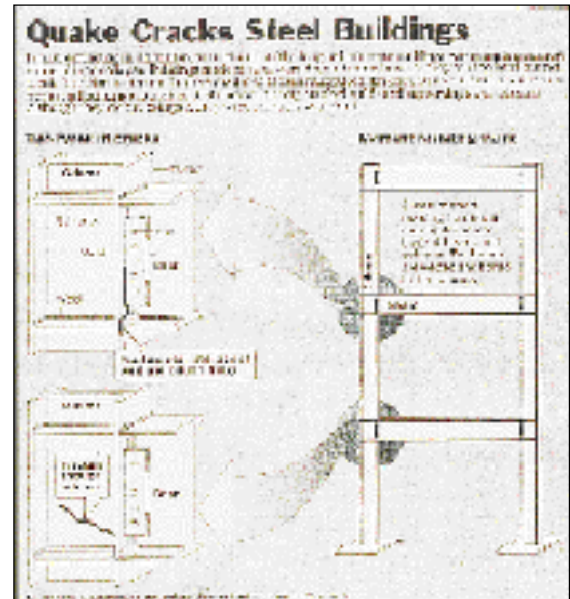
Figure 23. Though no steel-frame buildings collapsed, cracks in connections have stimulated efforts to substantiate building code requirements.

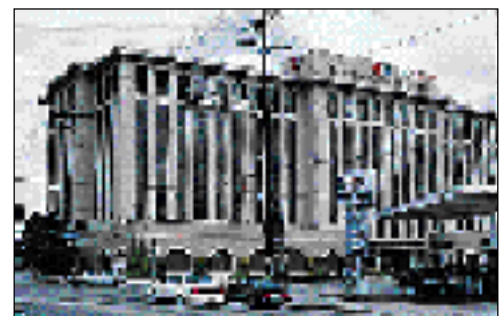
Figure 24. Cracks in slightly damaged steel buildings were often undetected until months after the earthquake.

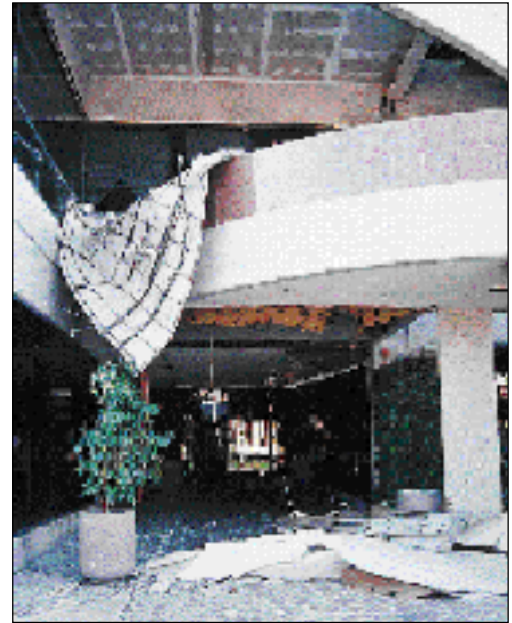
Figure 26. Heavy plaster ceilings or soffits can pose serious risks to occupants.

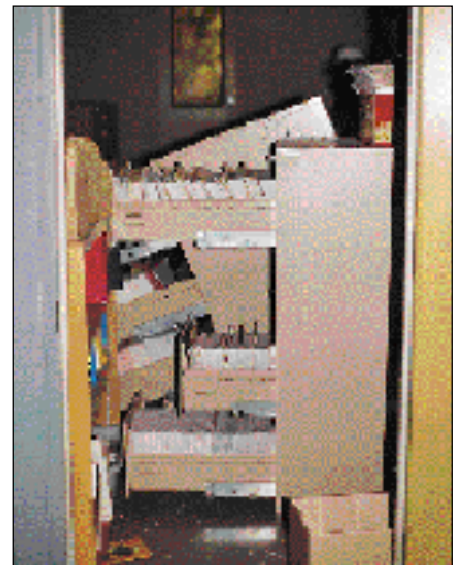
Figure 27. Unsecured tall, heavy furniture can strike or trap occupants. Building owners, managers, and occupants are primarily responsible for securing them.

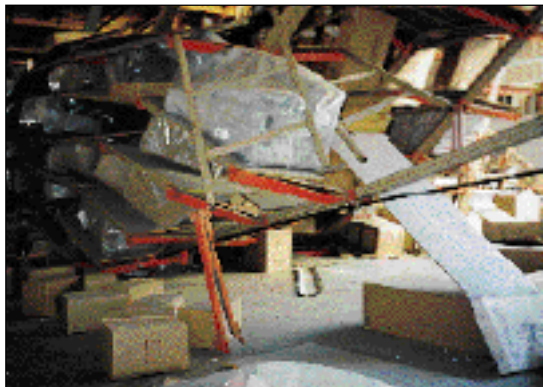
Figure 29. Collapsed storage racks would have posed substantial risks to life had this building been occupied during the earthquake.

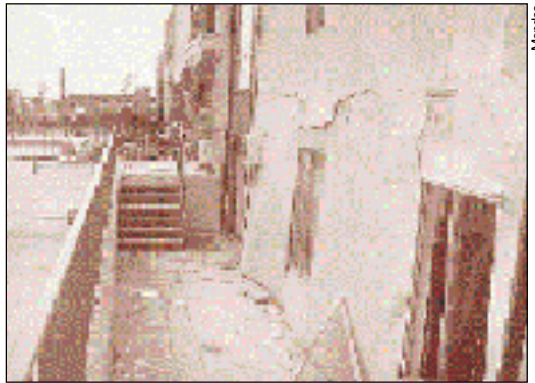
Figure 41. Damage from the 1971 earthquake in this apartment was similar to damage in the 17 ghost towns created by the Northridge earthquake.

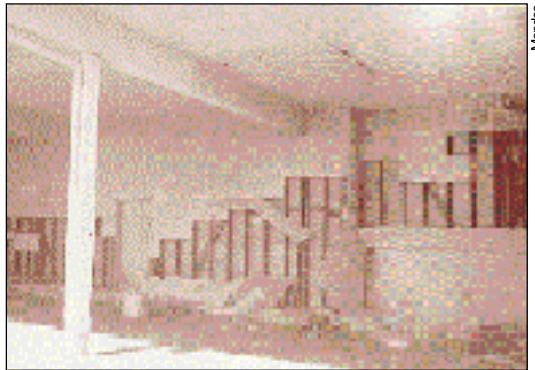
Figure 42. Walls in this building were repaired and retrofitted with plywood after 1971. In 1994 it suffered only minor damage.

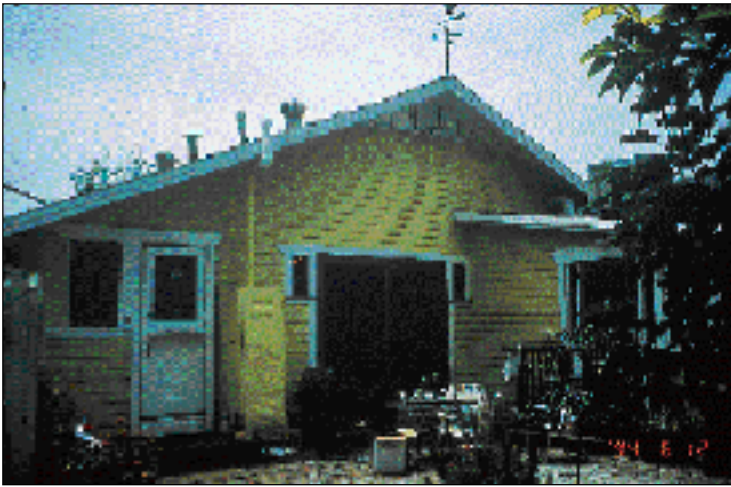
Figure 43. This home was retrofitted just prior to the earthquake and sustained far less damage than similar, unretrofitted homes in the neighborhood.

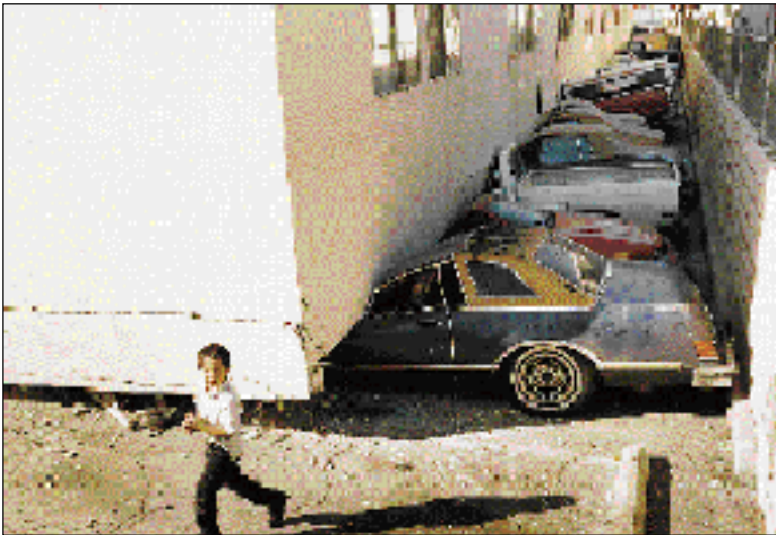
Figure 45. Older apartments like this with tuck-under parking collapsed because they were poorly braced.

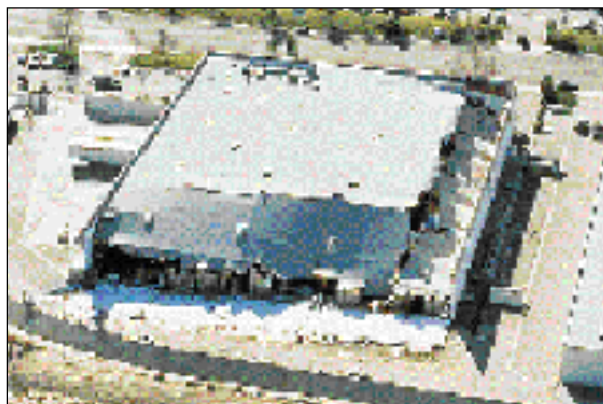
Figure 50. Despite changes to the building code made shortly after the 1971 earthquake, failures occurred in tilt-up buildings.

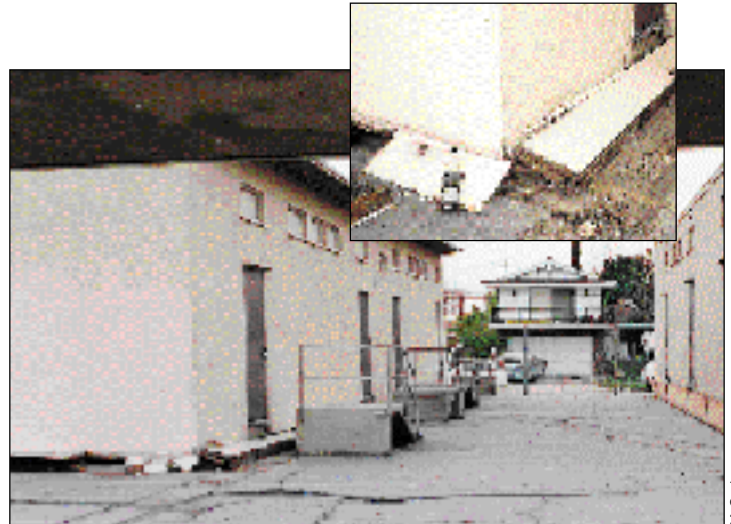
Figure 62. Several portable classrooms were seriously damaged after falling from weak or poorly maintained foundations. Inset, detail.
