# Geologic and Geotechnical Aspects of the Northridge Earthquake

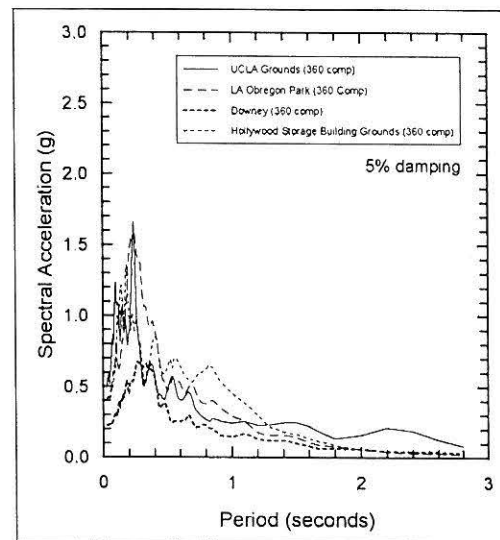
**Figure 9.** Example of Northridge earthquake response spectra.

Response spectra are graphs that display the response of structures to ground motion associated with earthquakes (Figure 9 is an example). A spectrum graphically depicts the variation of spectral accelerations (velocities or displacements) experienced by simple structures with different stiffnesses or periods of vibration (expressed in seconds). Although some recorded

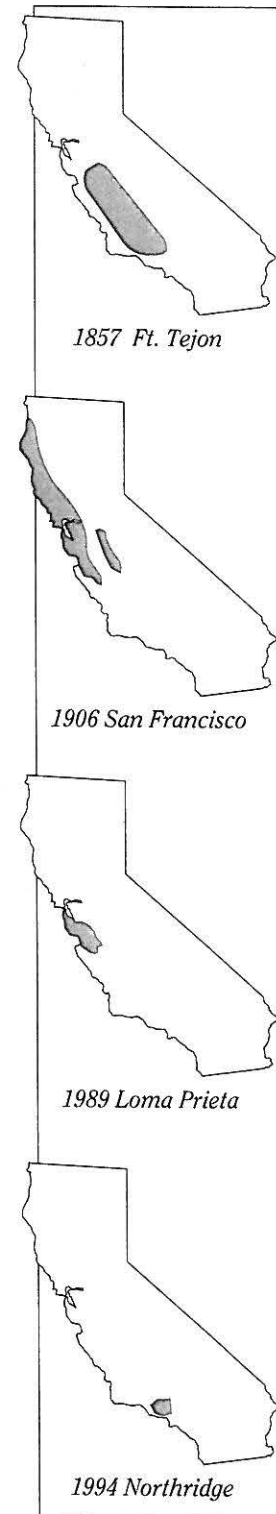
Figure 7. Map showing the area of intensity level VII and greater for selected historic California earthquakes.

quake affects a larger area and lasts longer, it can be expected to cause greater damage. Figure 7 compares areas subjected to intense shaking from four earthquakes, including Northridge.
