# Seismic Safety Commission Findings

A Report to the Governor and the Legislature on  
Lessons Learned from Recent Earthquakes  
In Turkey, Greece, and Taiwan

June 2000  
SSC 00-03

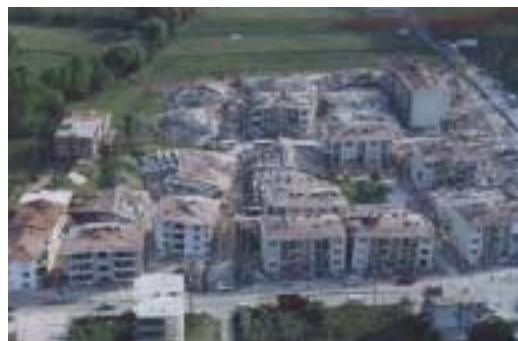
*Figure 1. Concrete building collapses in Gölcük after the August 17<sup>th</sup> Kocaeli Earthquake in Turkey.*

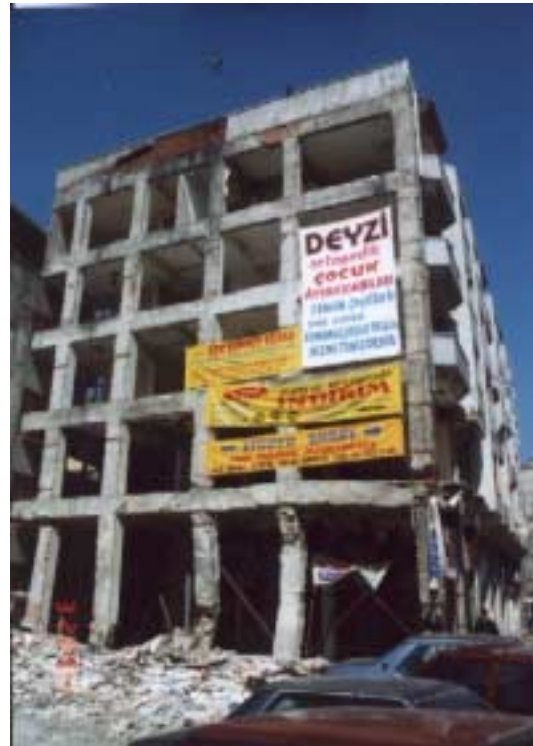
Figure 2. Severely damaged concrete building in Düzce, Turkey.

With few major exceptions, the Turkish Building Code has similar provisions to the codes used in California. However, Turkish buildings often rely on tall, slender concrete walls that are not typical in California. New unreinforced masonry wall construction, predominantly of hollow clay tile, is also allowed by the Turkish building code but is prohibited in California. Nevertheless, California has many older concrete frame buildings built before the mid-1970's that are expected to collapse in manners similar to those observed in Turkey. Similar examples of such collapses occurred in the

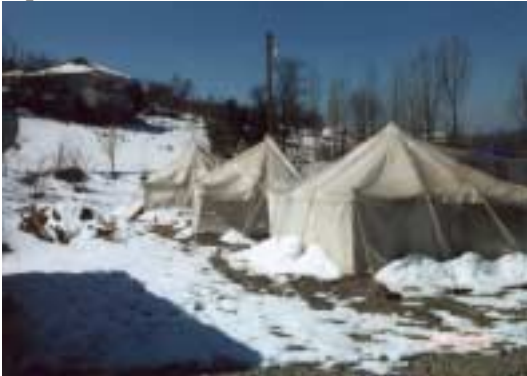
*Figure 3. Turkey made worldwide requests for “winterized” tents.*

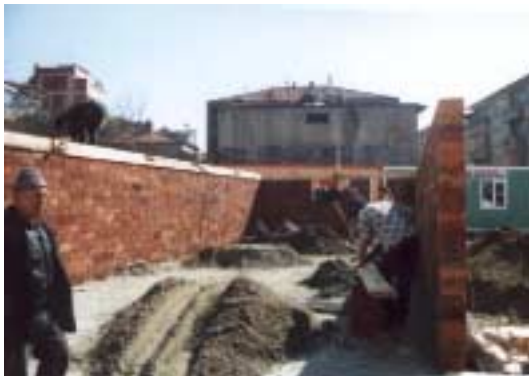
*Figure 4. New unreinforced masonry under construction on the site of a collapsed concrete building in Düzce, Turkey.*

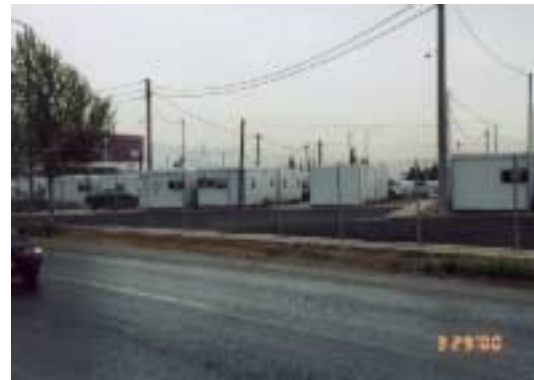
*Figure 5. Those remaining homeless from the 100,000 displaced in Greece are now living in prefabricated units such as these.*

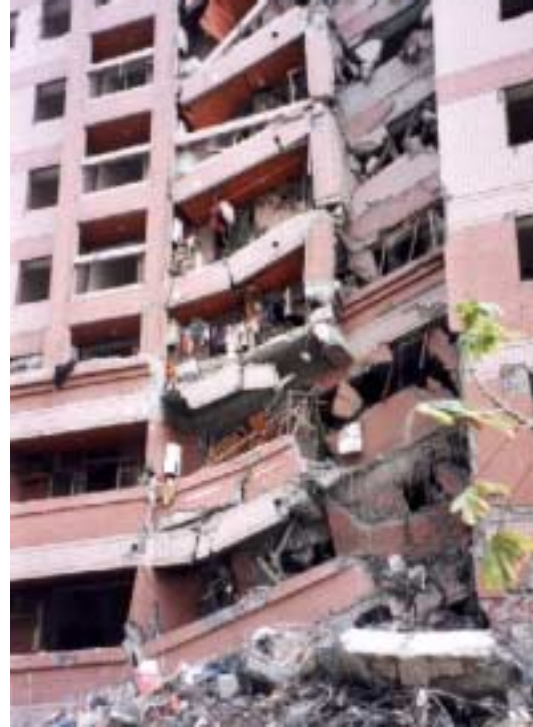
*Figure 6. Concrete building in Taichung that partially collapsed.*

design and lapses in code enforcement. Many high-rise buildings (less than 50 meters) that collapsed were constructed without input from qualified engineers. Many collapses occurred due to inherent weaknesses of soft first stories. In some cases, it appeared that buildings that had qualified structural engineering design input did not carefully follow the design detailing during construction.

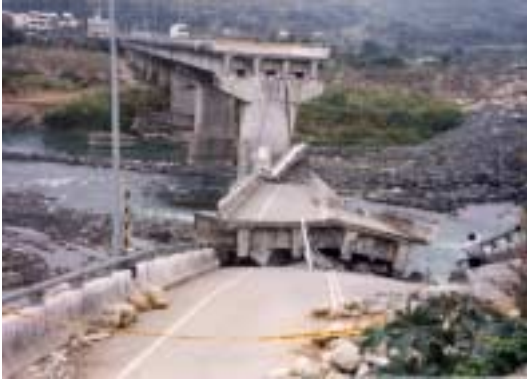
*Figure 7. Bridge collapsed due to fault rupture.*

This serves to emphasize the importance of enforcing geologic and geotechnical considerations before constructing critical and other facilities.

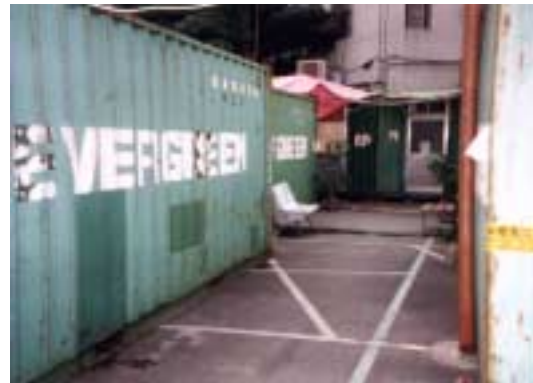
*Figure 8. Temporary housing and hospital facilities in Taiwan were created in cargo containers after the closure of hospitals due to earthquake damage.*

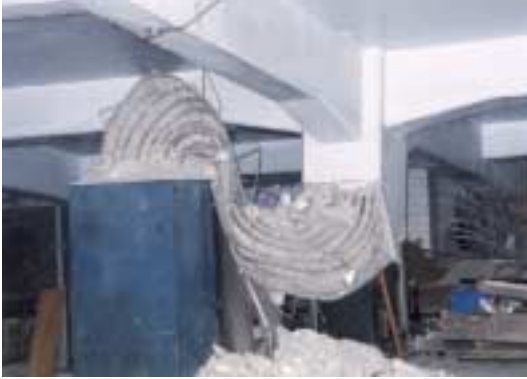
*Figure 9. This concrete column buckled due to inadequate reinforcing steel.*

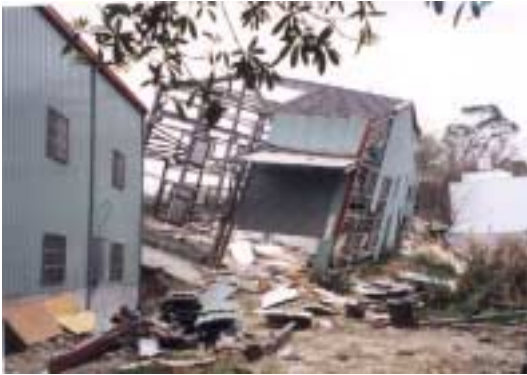
*Figure 10. Many structures were destroyed or damaged not only from the strong shaking, but also due to significant fault rupture.*

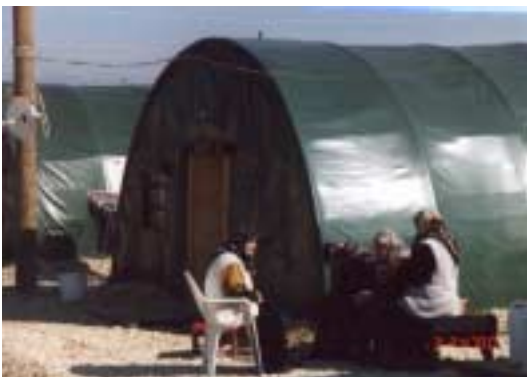
*Figure 13. Life in tent cities has settled into a routine. Most of the 211,000 still-displaced victims in Turkey are expected to continue to live in temporary and interim housing well into next year.*

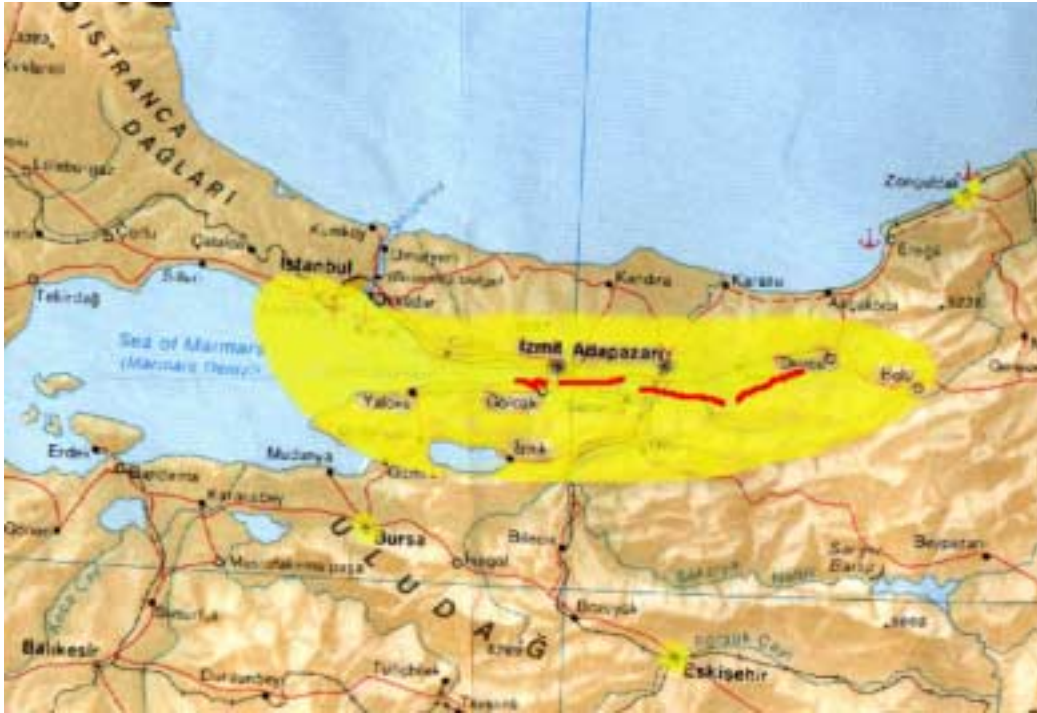
Figure 14. The yellow highlights indicate the approximate extent of strong ground shaking\* and life loss in the August 17<sup>th</sup>, 1999 Izmit, Kocaeli, Turkey Magnitude 7.4 Earthquake. (\*MMI VIII & greater from USGS 1193)

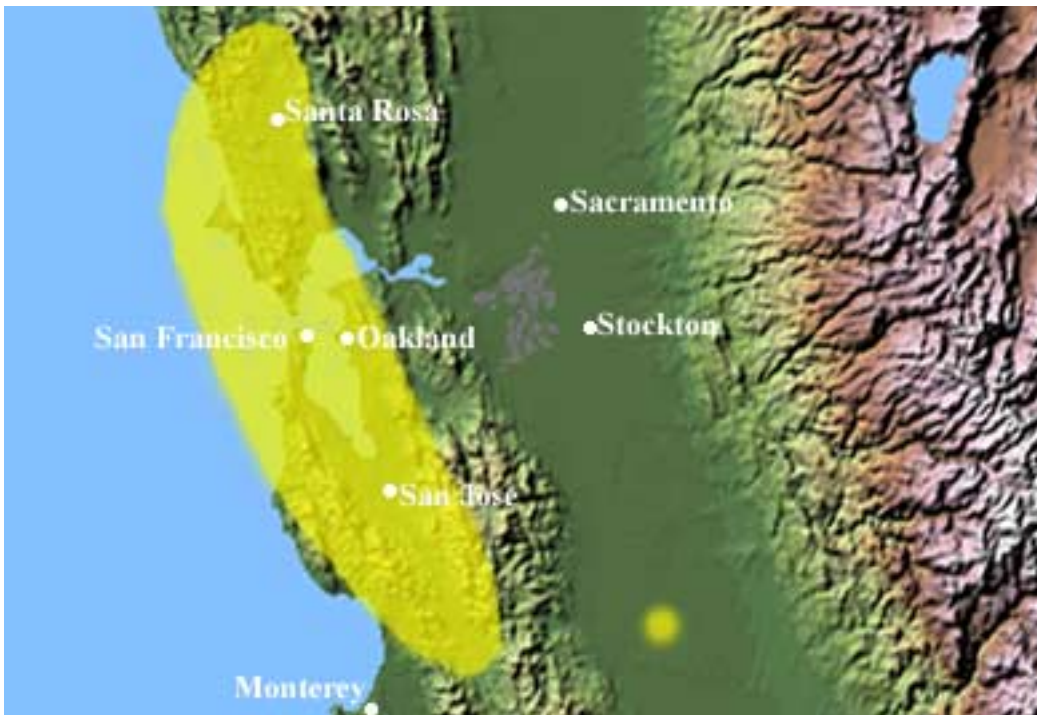
Figure 15. Yellow highlights from Figure 14 are overlaid to provide a rough indication of the areal extent of the effects of a hypothetical strike-slip fault with a similar magnitude 7.4, and with similar attenuation, site effects, and infrastructure vulnerability if it were to occur in Northern California.

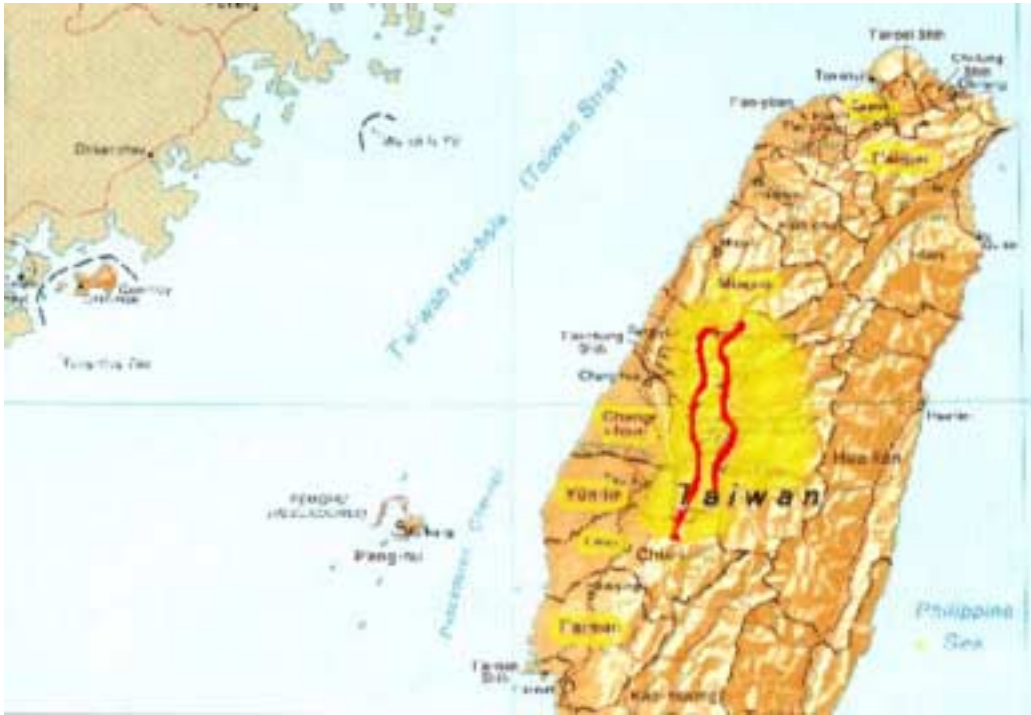
Figure 16. The yellow highlights indicate the approximate extent of strong ground shaking\* and life loss in the September 21, 1999 Taiwan magnitude 7.6 Earthquake. (\*PGA 40%g and greater from NCREE)

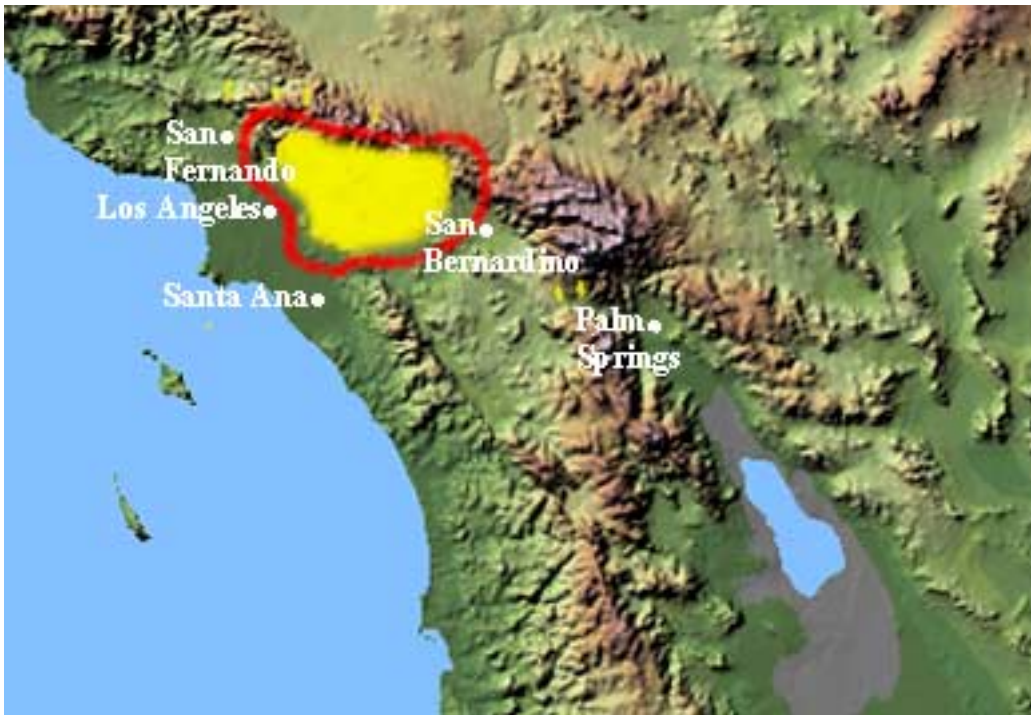
Figure 17. Yellow highlights from Figure 16 are overlaid for a rough indication of the areal extent of a hypothetical thrust fault scaled for a maximum Magnitude 7.0 earthquake expected on the Sierra Madre Fault assuming similar attenuation, site effects, and infrastructure vulnerability if it were to occur in Southern California. The red outline is similar in size to the region of strong shaking in the Magnitude 7.6 Taiwan Earthquake.
