CHAPTER III

Achieving Seismic Safety in Buildings

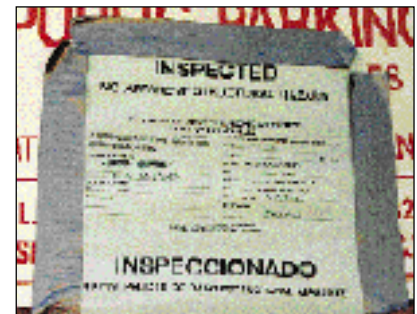
Figure 31. Typical “green tag” placard used to post buildings as safe to occupy. It states nothing about hazards from nonstructural elements or building contents.

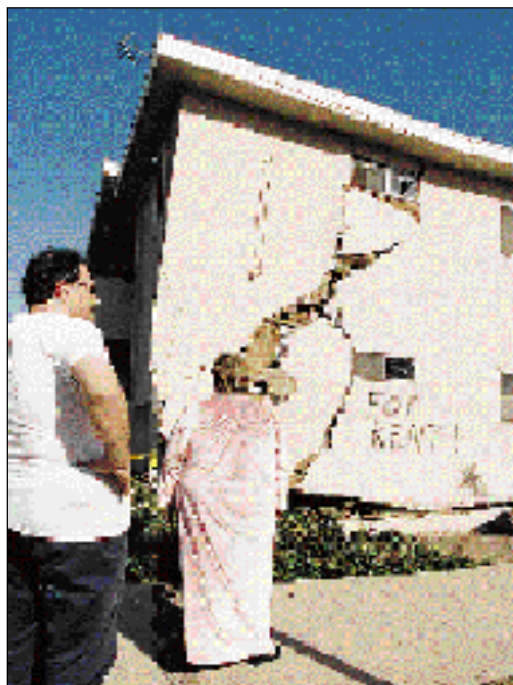
Figure 46. Damage to apartments caused more life and housing losses than other building types in this earthquake.

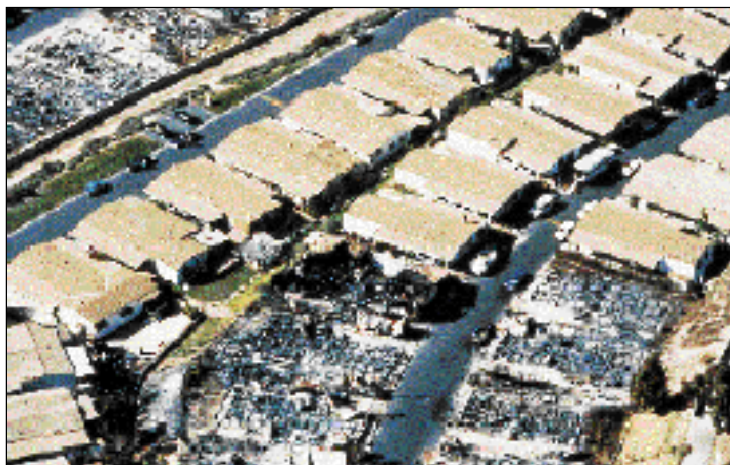
Earthquake-activated shut-off valves would probably have prevented some of the fires. However, according to HCD, some of the mobile homes that burned had shifted several feet and severed their gas lines, so individual earthquake-activated gas shut-off valves at the homes would not have prevented these fires. Fires also were started when water heaters toppled and severed their gas lines. Redesigning the gas connections for individual mobile homes to reduce the chance of breakage and installing master shut-off valves that cut off the gas flow at park entrances will reduce the risk of fire. Figure 47 depicts fire damage to mobile homes.

Figure 47. One hundred seventy-two mobile homes burned in this earthquake. Fires most often started because of severed gas lines.

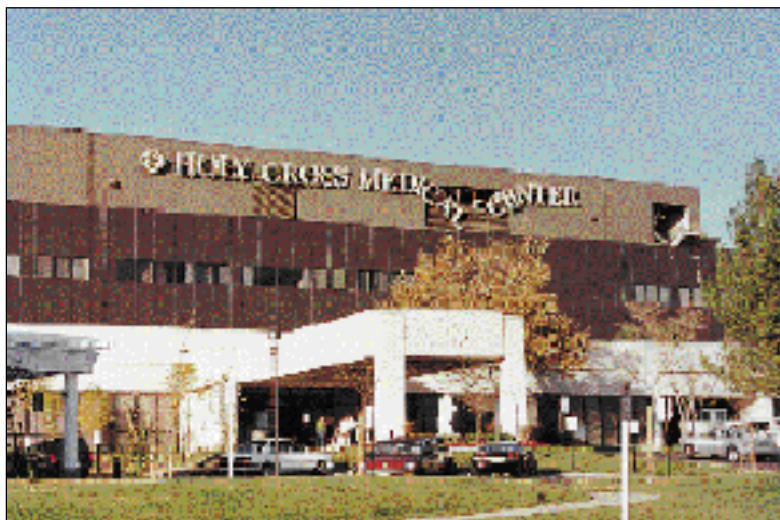
- Sprinkler and other water line breaks and leaks

- HVAC equipment anchorage failures
- Large oxygen tank base failures; leaning tanks
- Toppling of unanchored cabinets and equipment
- Communications failures
- Elevator damage
- Firefighting system failure
- Medical gas failure (except Northridge)
- Backup power outage (except Northridge and Holy Cross)
- Water service outage
- Gas service outage
- Electrical service outage

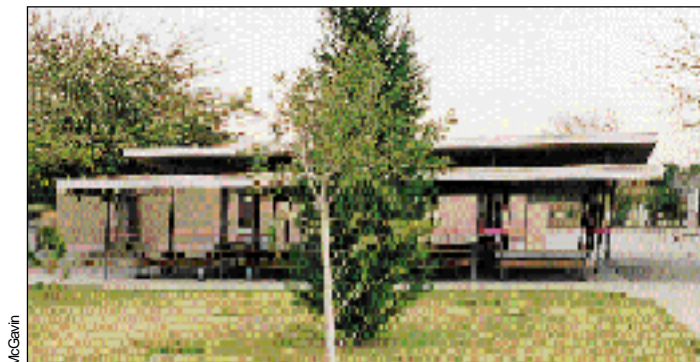
These structures normally consist of flat wood-frame roofs supported on steel or concrete vertical cantilever columns embedded in concrete foundations. Some cover large areas or extend for several hundred feet, and all usually connect or abut one or more buildings. The concrete columns are often subject to larger distortions than the adjacent classroom buildings. See figures 61 and 63.

Figure 63. The lunch shelter at Danube Elementary School leaned over about one foot.
