CHAPTER III

Achieving Seismic Safety in Buildings

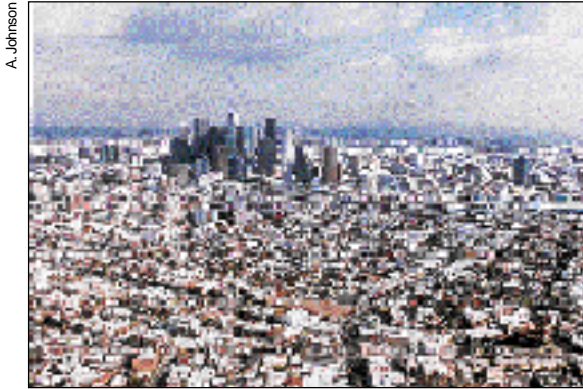
Figure 14. The Los Angeles region has over 8 million people in 3 million buildings, 240,000 of which were in regions of strong shaking during the Northridge earthquake.

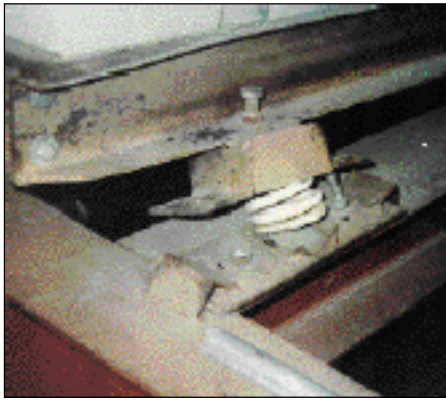
Interruption of essential functions, such as the failure of backup power generators at fire department dispatch centers (for example, Los Angeles City Fire Department) and hospitals (for example, Los Angeles County's Olive View Medical Center) have life safety consequences. Interruption of business functions, such as corporate data processing centers and unoccupiable industrial, commercial, and residential buildings, can have economic consequences that may exceed the cost to repair and replace damaged elements. In many buildings, damage to the mechanical systems, including heating, ventilating, and air conditioning (HVAC) equipment as shown in Figure 28, resulted in lengthy downtime.

Figure 28. Broken supports on heating and ventilating equipment can render this equipment useless.

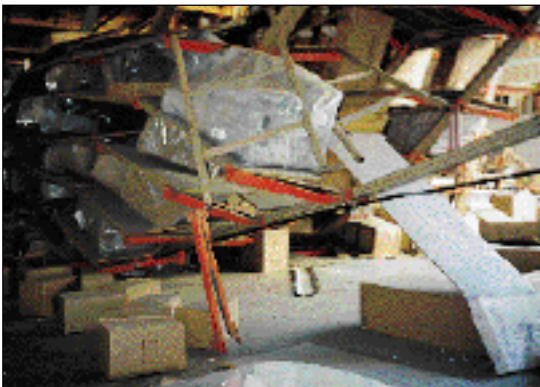
- Storage racks*, used in retail warehouse-type stores, performed well in some facilities but poorly in others. Heavy contents fell off racks as well (see Figure 29). The difference between acceptable and unacceptable performance appeared to be related to owners' differing policies. Owners of the better-performing racks purchased racks with heavy storage load ratings, loaded them to only about half their capacity, and kept upper-level items shrink-wrapped together in relatively large and stable blocks. Others purchased less sturdy racks, filled their space with heavy contents, and allowed individual items such as 5-gallon paint cans to be stacked on upper levels.

Figure 29. Collapsed storage racks would have posed substantial risks to life had this building been occupied during the earthquake.

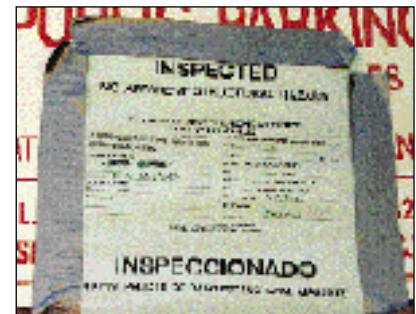
Figure 31. Typical “green tag” placard used to post buildings as safe to occupy. It states nothing about hazards from nonstructural elements or building contents.

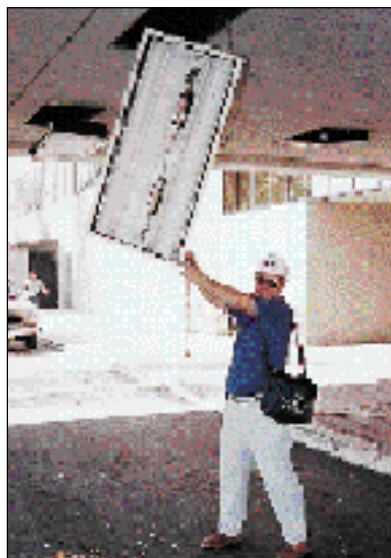
Figure 32. A light fixture partially fell when an anchor for one of its two safety wires pulled out at the Sylmar County (Olive View) Hospital.

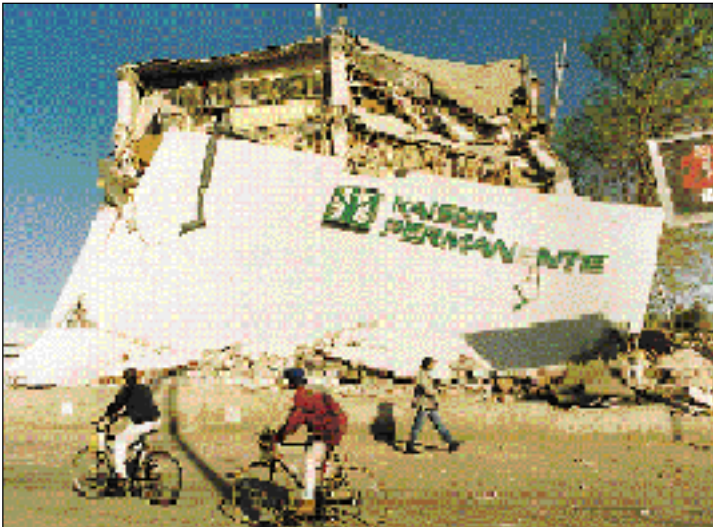
Figure 33. Both ends of this 1960s medical office building collapsed and the second floor “pan-caked.” Fortunately it was not occupied.

A number of building types are vulnerable to earthquakes, and in the Northridge earthquake they again demonstrated their potential to collapse and pose significant threats to life and loss of building functions. For example, the concrete columns and beams in buildings erected before the mid-1970s often lack reinforcing steel to keep them from collapsing or being damaged beyond repair in earthquakes. These buildings, like the ones shown in Figure 33, can pose the greatest threat to life in earthquakes because, though

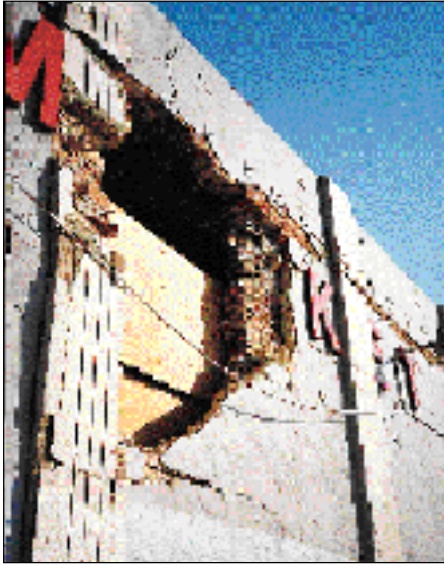
Figure 35. Although this retrofitted building lost a few bricks and may be difficult to repair, damage was significantly less than in similar unreinforced buildings. The outer layer of brick was not adequately connected to the inner layers.

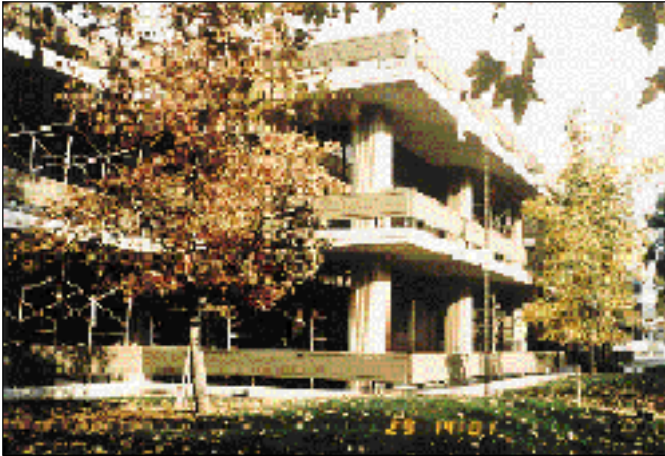
Figure 40. This building in Santa Clarita is shown during its 1993 retrofit which was undertaken with minimal disruption to its occupants. The building emerged from the Northridge earthquake with no structural damage.

behavior for lateral resistance. The building was strengthened in 1991 by adding new concrete beams above the floors in selected locations to form frames. These beams were designed to cause yielding in the new beams rather than the existing columns. The retrofit design was based on the 1988 UBC. This building experienced intense shaking with remarkably little damage (Figure 40).

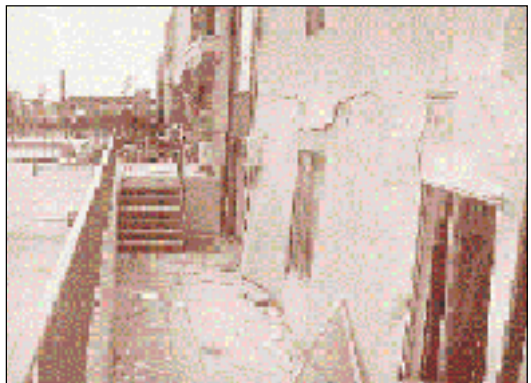
Figure 41. Damage from the 1971 earthquake in this apartment was similar to damage in the 17 ghost towns created by the Northridge earthquake.

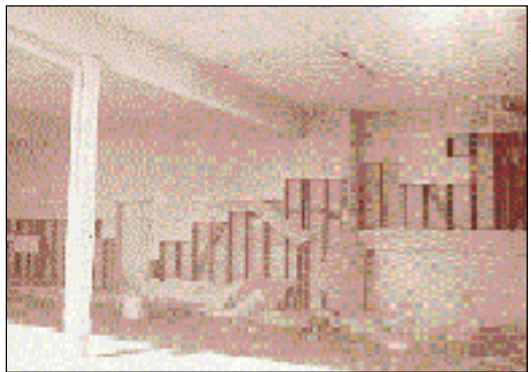
Figure 42. Walls in this building were repaired and retrofitted with plywood after 1971. In 1994 it suffered only minor damage.

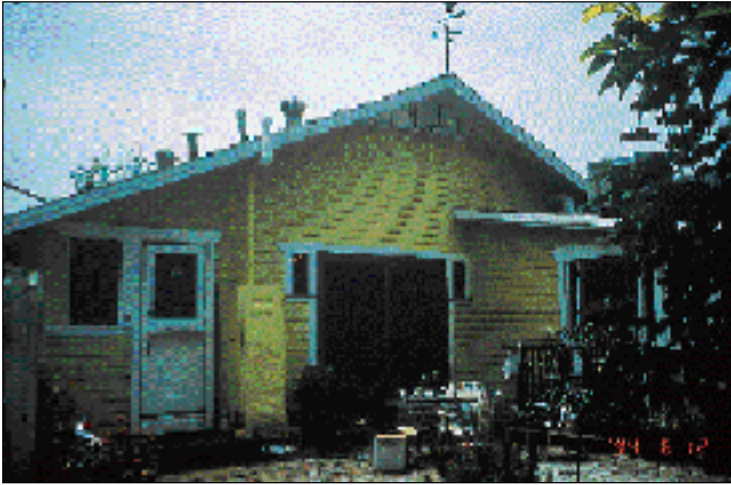
Figure 43. This home was retrofitted just prior to the earthquake and sustained far less damage than similar, unretrofitted homes in the neighborhood.

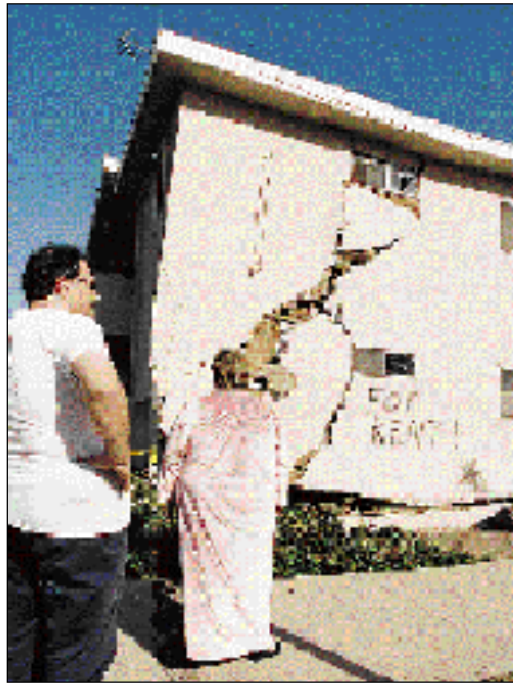
Figure 46. Damage to apartments caused more life and housing losses than other building types in this earthquake.

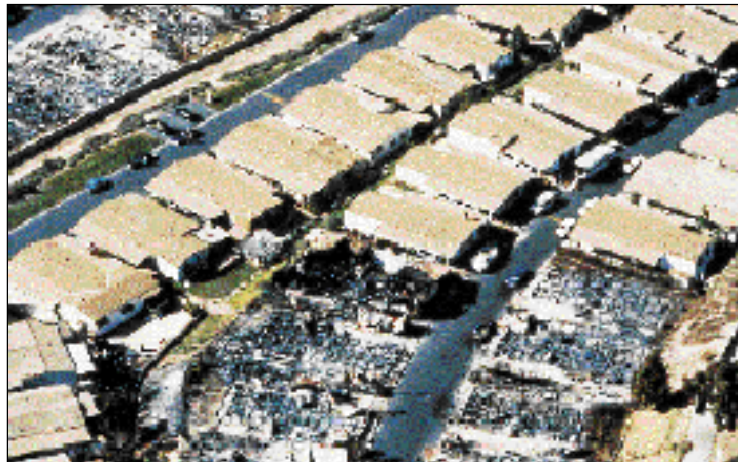
Earthquake-activated shut-off valves would probably have prevented some of the fires. However, according to HCD, some of the mobile homes that burned had shifted several feet and severed their gas lines, so individual earthquake-activated gas shut-off valves at the homes would not have prevented these fires. Fires also were started when water heaters toppled and severed their gas lines. Redesigning the gas connections for individual mobile homes to reduce the chance of breakage and installing master shut-off valves that cut off the gas flow at park entrances will reduce the risk of fire. Figure 47 depicts fire damage to mobile homes.

Figure 47. One hundred seventy-two mobile homes burned in this earthquake. Fires most often started because of severed gas lines.

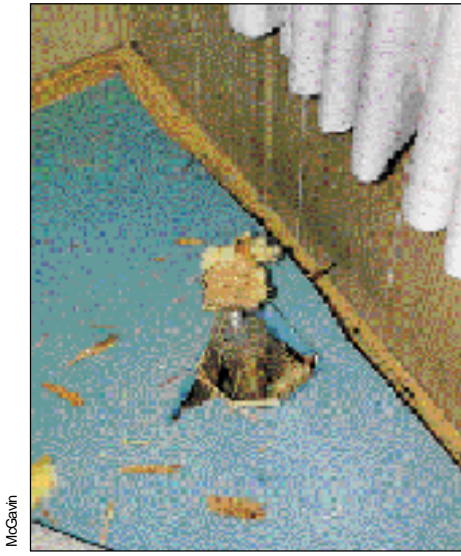
Figure 48. A steel jackstand pokes up through the floor of a mobile home after it shifted.

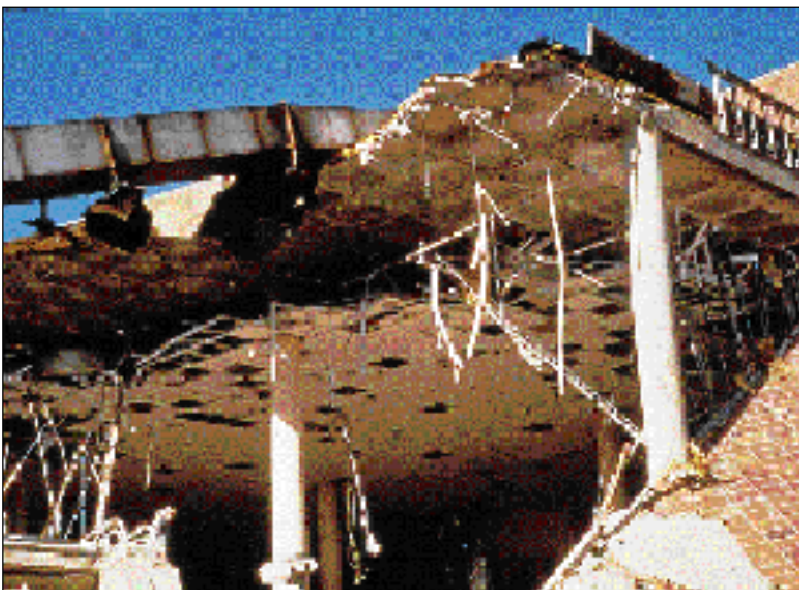
Figure 52. Connections between the roof and floor slabs and the columns failed in this collapsed building.

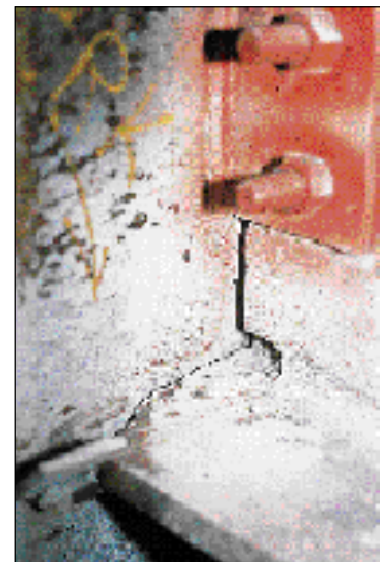
The Northridge earthquake caused unprecedented damage in a significant number of these modern buildings, primarily fractures near the beam-to-column welds and in the columns around the beam-to-column connections (see Figure 56). In most cases these failed connections were not readily apparent, as they are typically hidden by fireproofing, ceilings, and walls, but damaged steel buildings have been located both within and outside the areas of strongest shaking.

Figure 56. Steel-frame connections were unexpectedly cracked.

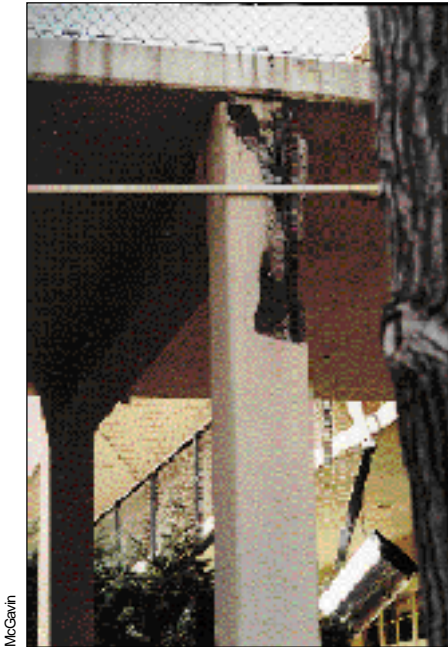
It is difficult to summarize the most typical kinds of failures or to make generalizations. There were cracks in walls, spalling of concrete columns at beam-column joints, and cracks in floors, particularly on-grade slabs. This typical structural damage was to be expected from force levels caused by intense shaking. The major portion of the damage was in structures constructed to pre-1976 building regulations, although statistics on performance are not conclusive since the heavily shaken area did not have major school construction in more recent times. An example of typical structural damage is shown in Figure 61.

Figure 61. Damage to a concrete column on a two-story elevated walkway at Patrick Henry Junior High School. Note the failure of the guardrail in the background.

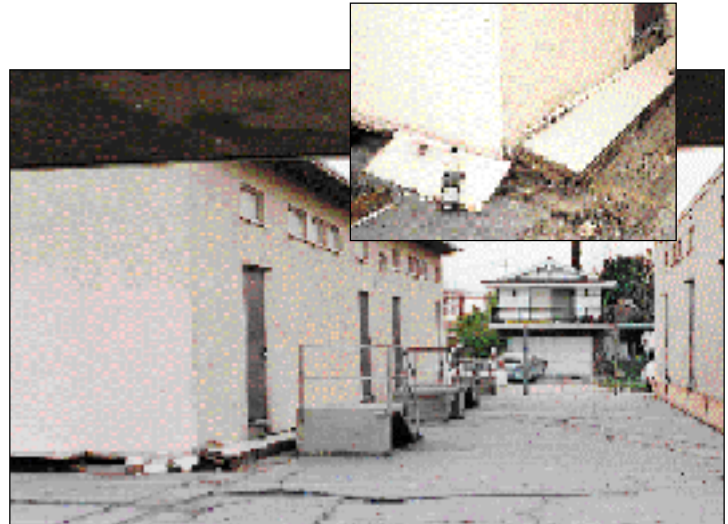
Several portable or relocatable classroom buildings were seriously damaged in the earthquake. Many units had foundation failures where the cripple walls were racked up to eight inches out of plumb. Some fell to the ground. These failures occurred in structures constructed prior to 1976 with wood foundations. Some were poorly maintained and showed evidence of rotting wood and a subsequent loosening of nails intended to resist seismic forces. See Figure 62.

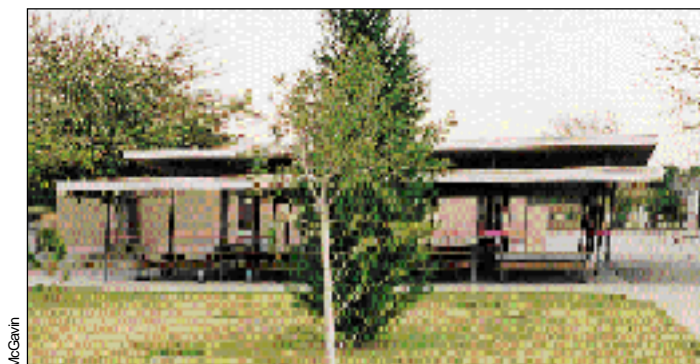
These structures normally consist of flat wood-frame roofs supported on steel or concrete vertical cantilever columns embedded in concrete foundations. Some cover large areas or extend for several hundred feet, and all usually connect or abut one or more buildings. The concrete columns are often subject to larger distortions than the adjacent classroom buildings. See figures 61 and 63.

Figure 63. The lunch shelter at Danube Elementary School leaned over about one foot.

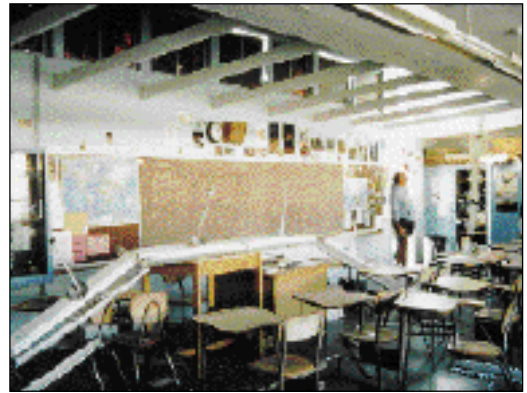
According to DSA, light fixtures fell onto desks or to the floor in approximately 100 classrooms. See Figure 64. Cracked partition walls, fallen ceiling tiles, overturned file cabinets, broken window panes, failed light fixture supports, and broken sprinkler water lines were evident in many school buildings located in the strongly shaken area. DSA found many methods for reducing nonstructural damage were quite effective.

Figure 64. Falling light fixtures in over 100 classrooms would have posed significant threats to students and teachers had the earthquake occurred during school hours.

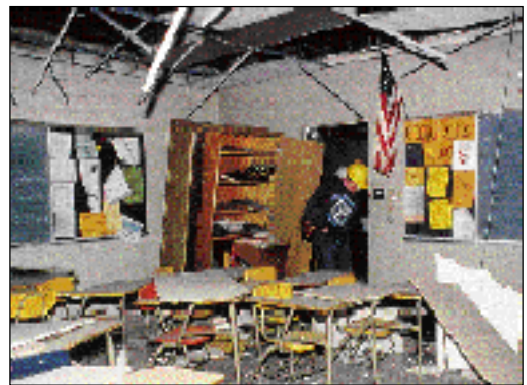
tive in this earthquake. The older buildings had proportionally more damage, which suggests that many of these hazards can be reduced by retrofitting existing schools with current methods (see Figure 65).

Figure 65. Though less life-threatening than light fixtures, ceiling tiles were a major property loss that could have been reduced with modern bracing techniques.

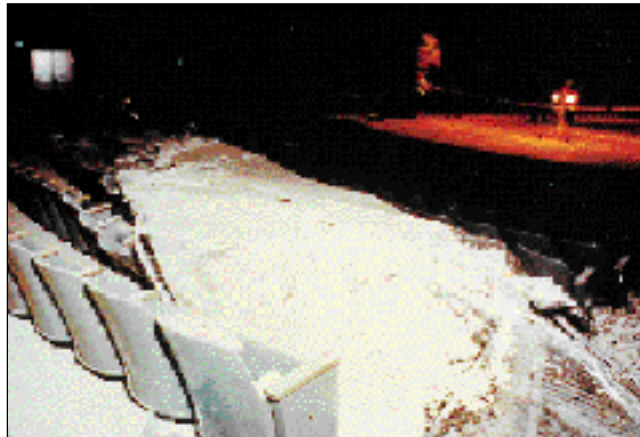
- Exterior plaster soffits* (exterior ceilings and overhangs) and wall finishes failed in several buildings that are considered modern (see Figure 26 and Figure 67). Under present inspection practices it is difficult to verify that these elements were constructed with adequate anchorage because several installation steps are involved, and detailed inspections of each phase are not a typical building inspection practice. Once in place, verification is even more difficult. Whereas the earthquake bracing of a lightweight suspended ceiling can usually be inspected by removing the

- *Royce Hall*, built in the 1920s, sustained structural damage. It is a popular symbol of the University and houses the main campus auditorium (see Figure 67) and classrooms for a diverse group of academic programs offered by the College of Letters, Arts, and Sciences. This structure had been identified as one of the seven "very poor," or most vulnerable, structures on campus. The structural damage was primarily in the two towers at the entrance. Because these towers stand over the main entrance, it was necessary to close the building. The seismic deficiency of these towers had been noted in a UCLA seismic committee review and a design team was in the process of designing seismic retrofit measures at the time of the earthquake.

Figure 67. Large sections of a heavy plaster ceiling came down in Royce Hall. At another time of day, injuries and possibly deaths would have resulted.
