CHAPTER IV

Achieving Seismic Safety in Lifelines

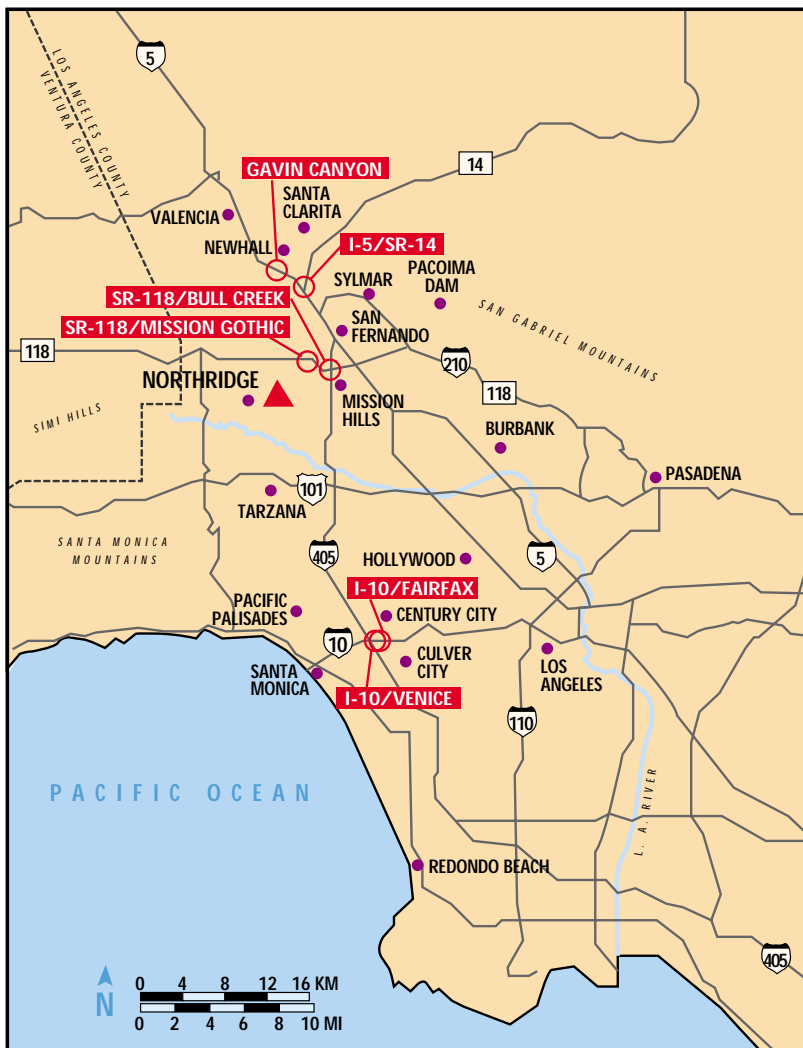
Figure 68. Location of collapsed overpasses.

The interchange of State Route 14 and Interstate 5 (see Figure 68 for locations) was badly damaged in the 1971 San Fernando earthquake, but the two structures that collapsed in the Northridge earthquake, the North and South Connector overcrossings, were designed before 1971. At that time it was believed that improved hinge restrainers would be adequate to prevent collapse. Though they contain some pre-1971 design details, hinge restrainers were added to both bridges. During the Northridge earthquake, brittle shear failures in short stiff columns next to the abutments initiated the collapse of both bridges as shown in Figure 69. After the columns failed in shear and were crushed by the weight of the decks, the decks were pulled from their supporting abutments. As the decks fell, they failed by bending at the adjacent piers. These failures demonstrated that retrofitting such structures with hinge restrainers alone may not be adequate. Retrofitting the single-column piers to

prevent brittle shear, moment, and foundation failures may also be needed. Caltrans has incorporated this observation in the design of both retrofitted and new projects.
