CHAPTER III

Achieving Seismic Safety in Buildings

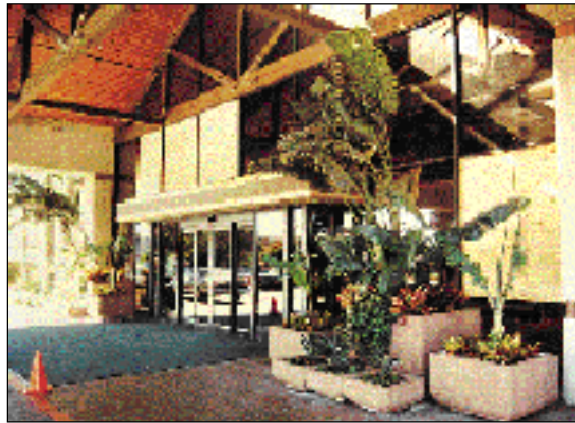
Breakage of glass often occurs at entries to buildings, a location that maximizes the potential for injuries. Aftershocks are a particular danger with this nonstructural component. The broken panes pictured in Figure 30 were misaligned and some cracked in the main shock at 4:31 a.m., but it was an aftershock that caused the panes to fall out. Figure 31 shows how such buildings are posted with placards, raising the issue of whether nonstructural post-earthquake safety criteria need more emphasis.

Figure 30. Large broken windows at a hotel entrance pose major falling hazards.

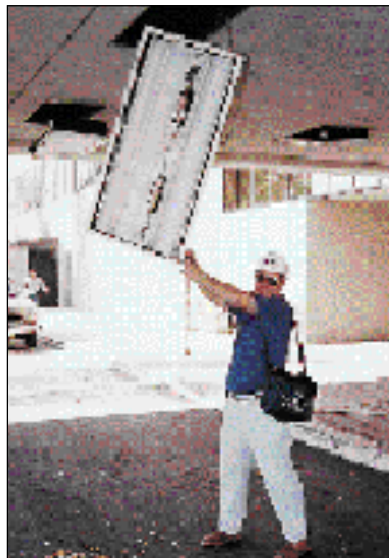
Figure 32. A light fixture partially fell when an anchor for one of its two safety wires pulled out at the Sylmar County (Olive View) Hospital.

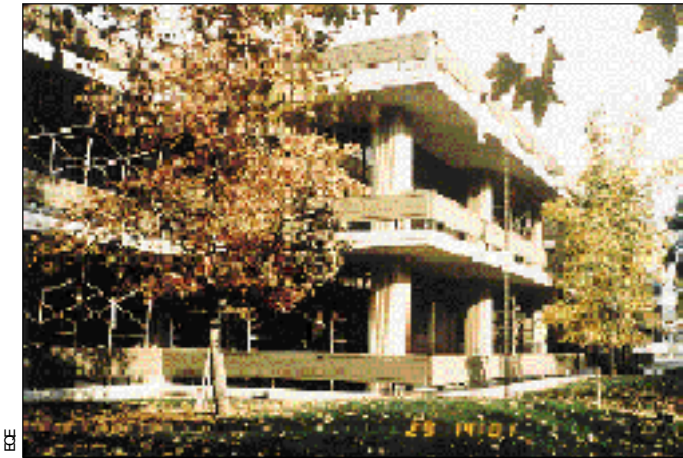
Figure 40. This building in Santa Clarita is shown during its 1993 retrofit which was undertaken with minimal disruption to its occupants. The building emerged from the Northridge earthquake with no structural damage.

behavior for lateral resistance. The building was strengthened in 1991 by adding new concrete beams above the floors in selected locations to form frames. These beams were designed to cause yielding in the new beams rather than the existing columns. The retrofit design was based on the 1988 UBC. This building experienced intense shaking with remarkably little damage (Figure 40).

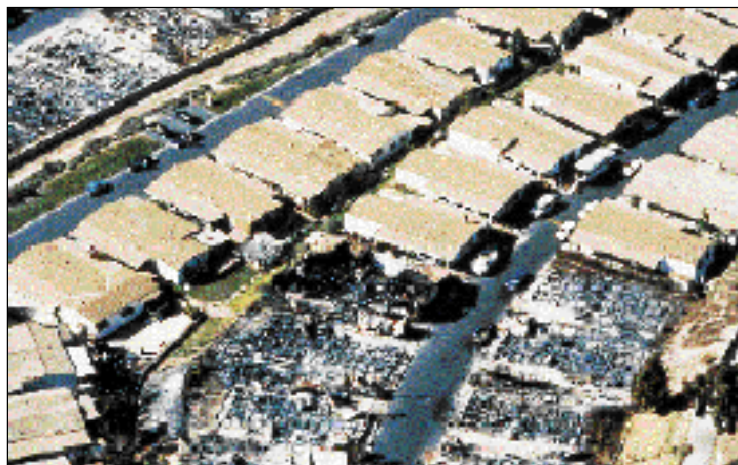
Earthquake-activated shut-off valves would probably have prevented some of the fires. However, according to HCD, some of the mobile homes that burned had shifted several feet and severed their gas lines, so individual earthquake-activated gas shut-off valves at the homes would not have prevented these fires. Fires also were started when water heaters toppled and severed their gas lines. Redesigning the gas connections for individual mobile homes to reduce the chance of breakage and installing master shut-off valves that cut off the gas flow at park entrances will reduce the risk of fire. Figure 47 depicts fire damage to mobile homes.

Figure 47. One hundred seventy-two mobile homes burned in this earthquake. Fires most often started because of severed gas lines.

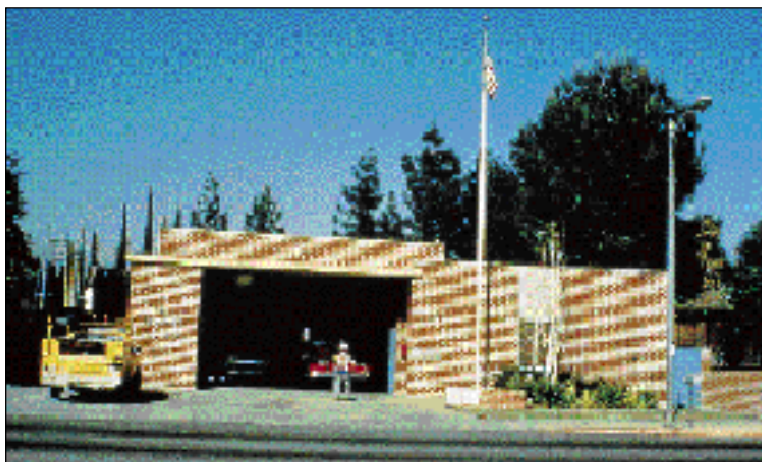
Inoperable doors on fire stations continue to cause serious emergency-response problems. The large openings in the front of typical fire stations tend to create front walls that are inadequately braced and not stiff enough to prevent large amounts of drift, or movement, during earthquakes. Extensive building displacements can jam the doors. If the doors are down when

Figure 60. Most fire stations like this one (Northridge Station 107) sustained little or no structural damage, but some had exit and garage doors that were stuck closed.

- Legislation be enacted to require state and local agencies to review all pre-1986 essential services facilities for their ability to function after earthquakes and that those found deficient be retrofitted.

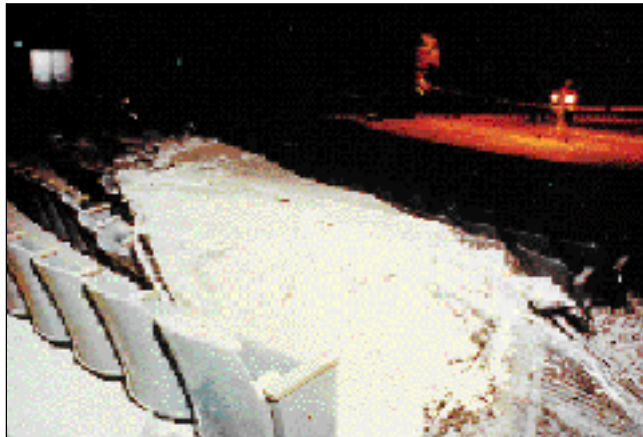
- *Exterior plaster soffits* (exterior ceilings and overhangs) and wall finishes failed in several buildings that are considered modern (see Figure 26 and Figure 67). Under present inspection practices it is difficult to verify that these elements were constructed with adequate anchorage because several installation steps are involved, and detailed inspections of each phase are not a typical building inspection practice. Once in place, verification is even more difficult. Whereas the earthquake bracing of a lightweight suspended ceiling can usually be inspected by removing the

- *Royce Hall*, built in the 1920s, sustained structural damage. It is a popular symbol of the University and houses the main campus auditorium (see Figure 67) and classrooms for a diverse group of academic programs offered by the College of Letters, Arts, and Sciences. This structure had been identified as one of the seven "very poor," or most vulnerable, structures on campus. The structural damage was primarily in the two towers at the entrance. Because these towers stand over the main entrance, it was necessary to close the building. The seismic deficiency of these towers had been noted in a UCLA seismic committee review and a design team was in the process of designing seismic retrofit measures at the time of the earthquake.

Figure 67. Large sections of a heavy plaster ceiling came down in Royce Hall. At another time of day, injuries and possibly deaths would have resulted.
