**State of California
Alfred E. Alquist
Seismic Safety Commission**

***The Field Act and its Relative Effectiveness in
Reducing Earthquake Damage in
California Public Schools
Appendices***

October 2009

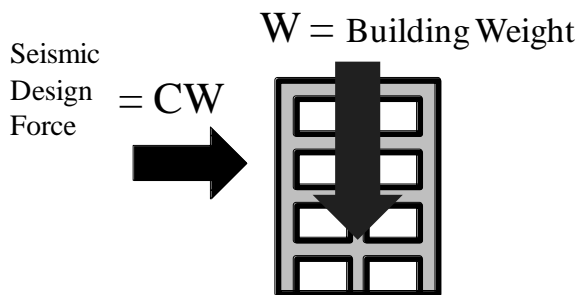
Figure F-1. Horizontal seismic design force as a percentage of total building weight

The first Field Act seismic provisions for public schools were based on the seismic requirements suggested by the 1927 UBC and required school buildings to be designed for lateral forces of two to ten percent of the building weight with most school buildings falling in the six to ten percent range. In comparison, the enactment of the Riley Act in 1933 set minimum seismic design standards for all (non-Field Act) buildings in California which, for most buildings, required a seismic design force of three percent of their weight.

From 1933 to 1976, the design earthquake forces on buildings in California were similar to those of school buildings and varied from 2 to 13% of the building weight, depending on the type of structural system and soil strength. Cities in high seismicity areas, such as San Francisco and Los Angeles often adopted more detailed guidelines than the UBC, based on growing knowledge in the field of structural dynamics and earthquake engineering. Similarly, public schools were designed using more detailed guidelines. Following the 1971 San Fernando Earthquake, which caused extensive damage to numerous buildings in the Los Angeles area, major changes appeared in the 1976 UBC. Some of the significant changes found in the 1976 UBC included increased design force levels (particularly for concrete and masonry structures), requirements to limit the horizontal swaying of the building when subjected to earthquake shaking, and revisions to the map defining earthquake hazard zones. In addition, an occupancy factor was added that increased the seismic design force for “essential” facilities, such as hospitals and fire stations and also for buildings where groups of more than 300 persons assembled. Most of the changes made to the 1976 UBC were adopted, effective July 1, 1978, by the Building Standards Commission and were included in the CBC for public schools.
