**State of California  
Alfred E. Alquist  
Seismic Safety Commission**

***The Field Act and its Relative Effectiveness in  
Reducing Earthquake Damage in  
California Public Schools***

**October 2009**

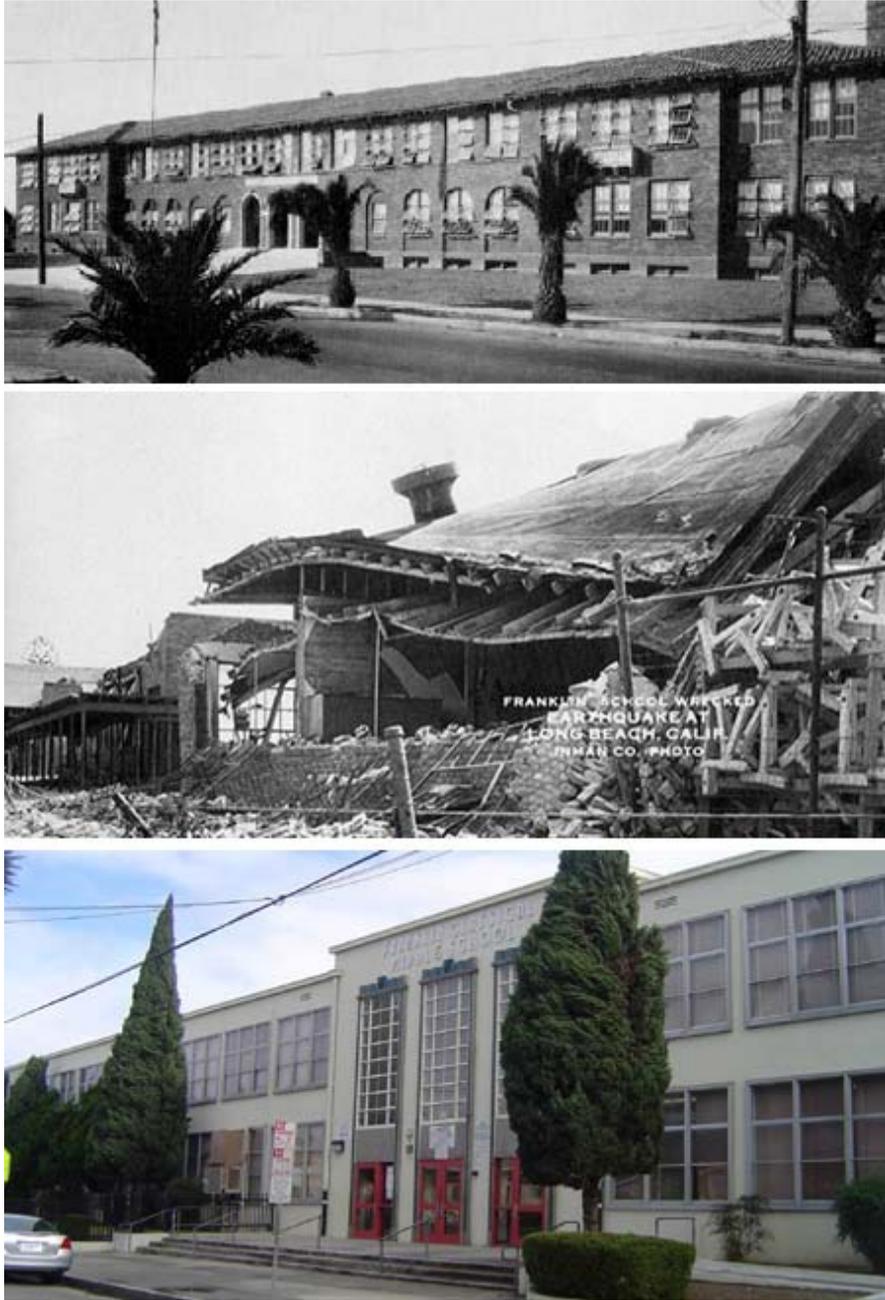
Figure 1: Pictures of the Franklin Junior High School in Long Beach. Top: before the 1933 Long Beach Earthquake; Middle: after the earthquake; Bottom: the rebuilt school today. (Photo Credit: California Geological Survey – accessed from CGS website on May 10, 2009)

The Magnitude 6.4 Long Beach Earthquake of 1933 resulted in 70 schools being destroyed entirely, as was shown in Figure 1, and another 120 schools experiencing major damage and 300 schools incurring minor damage (Meehan 1982). It was fortuitous that the earthquake occurred at 5:54 p.m., outside school hours, thus minimizing injuries and fatalities of children. This poor performance of, and the extensive damage to, public school buildings resulted in the enactment of Assembly Bill 2342, later officially titled *The Field Act*, after then Assemblyman C. Don Field. This act was signed by the Governor of California on April 10, 1933 – one month after the earthquake.

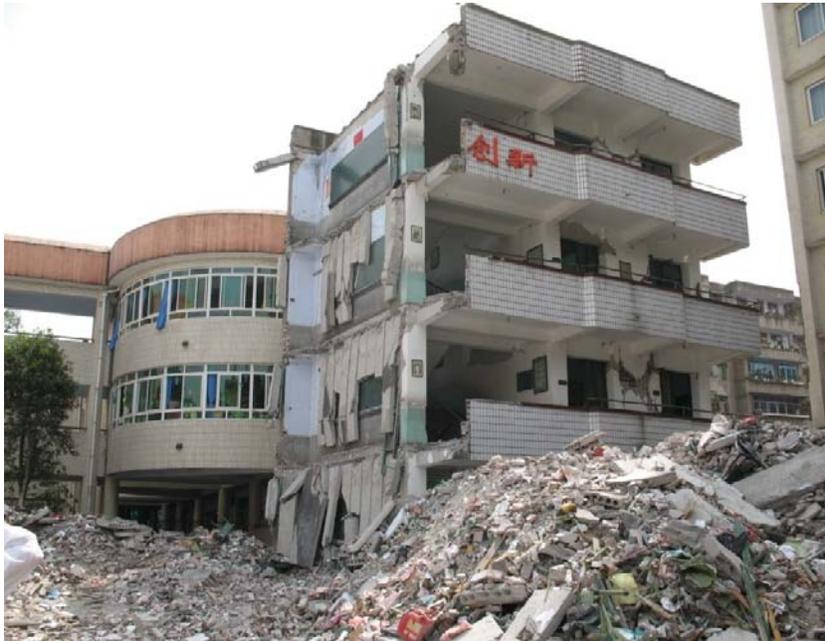
Figure 2: Damage to Elementary School in Xing Fu Township, Dujiangyan, during the 2008 Magnitude 8 Wenchuan Earthquake in China  
(Photo Credit: Miyamoto International)

Significant earthquake damage to schools has occurred in many other countries. During the May 12, 2008 Magnitude 8 Wenchuan Earthquake in China, there were 69,222 casualties, 374,638 wounded, and 18,176 missing (Yan et al. 2009). Approximately 6,900 school buildings collapsed (Yomiuri Shimbun 2009). Of the 6,581 casualties in the Sichuan Province education system, 6,376 were students, 1,274 people were missing, and 1,107 people were buried (Zhang and Li 2009). There is now a movement in China proposing that China adopt practices similar to California's Field Act to ensure safety of their schools (Li H. 2009). Figure 2 shows one of many school buildings that were destroyed.

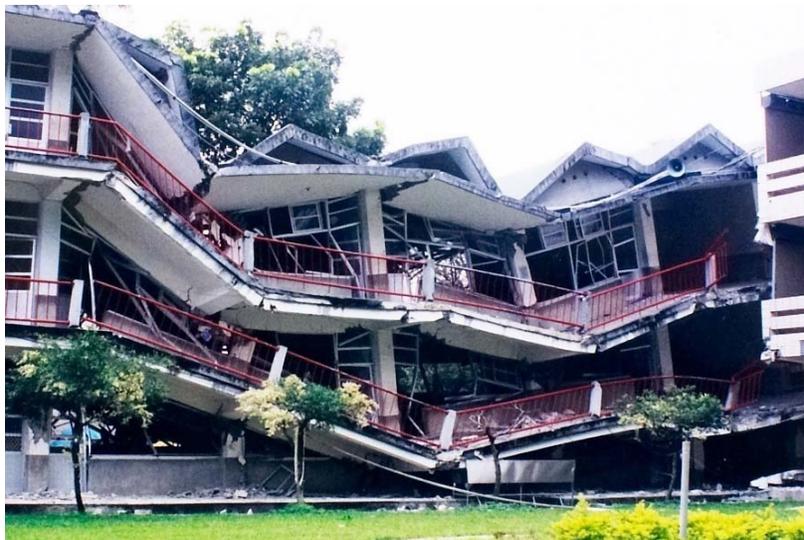
Figure 3: Damage to High School during the 1999 Chi-Chi Earthquake. (This collapsed school building has now been converted into a national museum.)  
(Photo Credit: Wei-sen Lee, National Science and Technology Center for Disaster Reduction, Taipei, Taiwan)
